## Australian Gold Mine Turns to CHEMCLAD & CeramAlloy to Save Pump Operating in 15% Hydrochloric Acid!

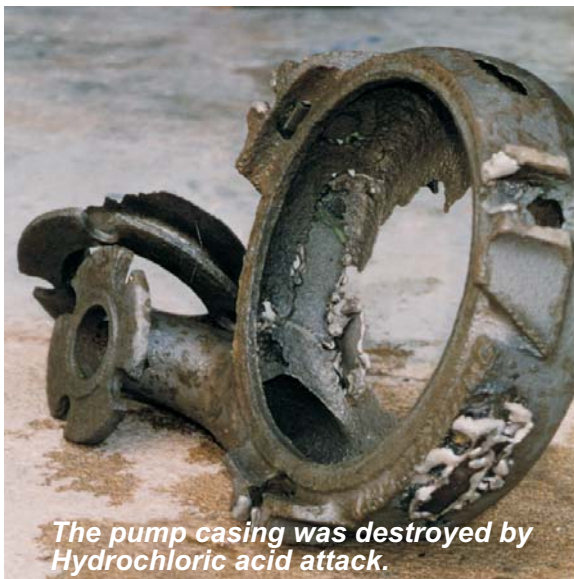
*The pump casing was destroyed by Hydrochloric acid attack.*

The pump was running in 15% Hydrochloric acid and, as you can see, it has been attacked from the outside as well as the inside!
