## Power Plant In The Philippines Chooses CHEMCLAD & CeramAlloy To Repair & Protect Critical FGD Pipeline

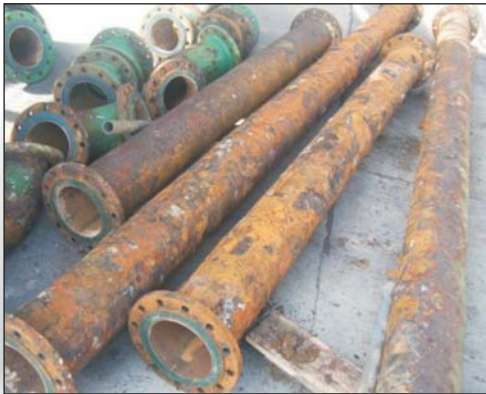
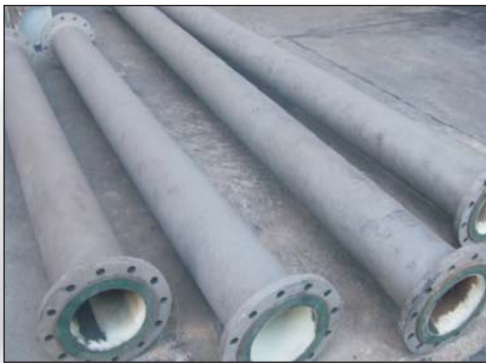
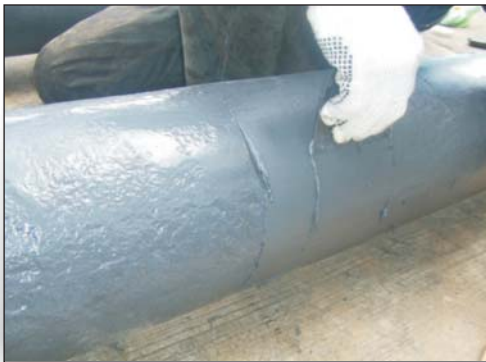
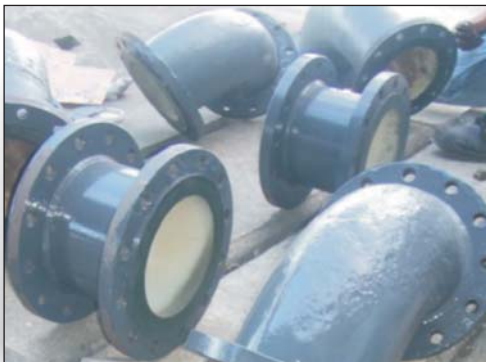
The make-up pipeline for the Flue Gas Desulfurization (FGD) section of this power plant in the Philippines was severely damaged by corrosion.

All components were first thoroughly prepared by grit blasting. An initial coat of CHEMCLAD SC was then applied to all surfaces.

CeramAlloy CP+[AC] was then applied to rebuild all the deeply pitted areas, followed by a final coat of CHEMCLAD SC to complete the application.
