ENECON Italia Solves Cavitation Problems For Ferry Boat Operator

Cavitation problems
on a ferryboat's
salt-water discharger
repaired and
protected from
future attack with
DuraTough DP & DL

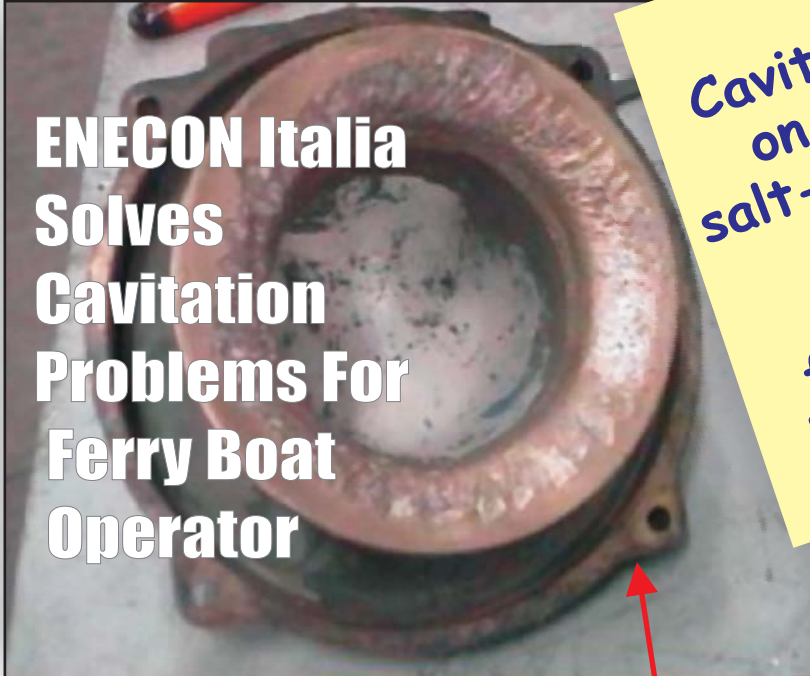
Severe cavitation damage clearly evident on discharger after grit blasting/cleaning.
