FLEXICLAD Repairs Cavitated Pump in Puerto Rico

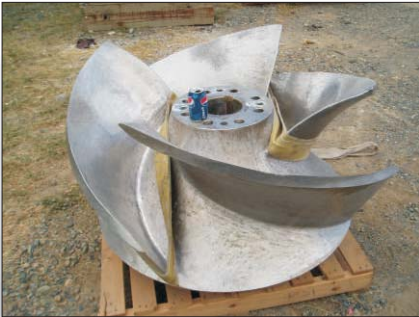
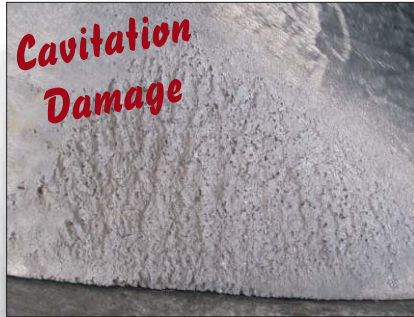
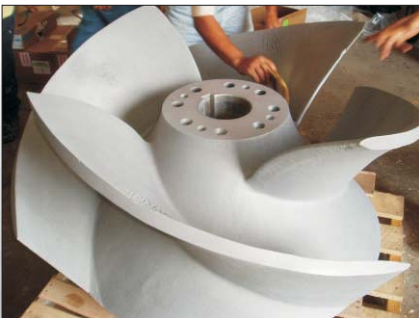
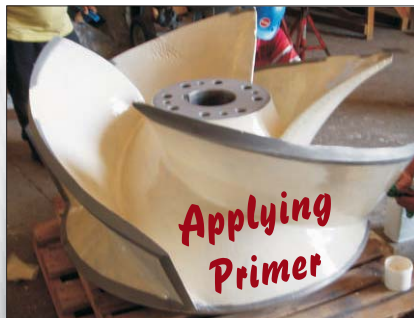
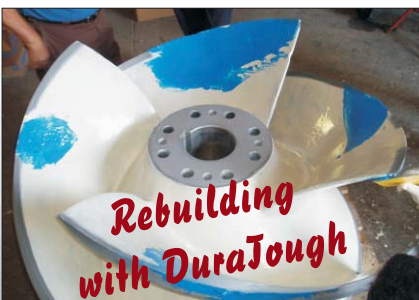
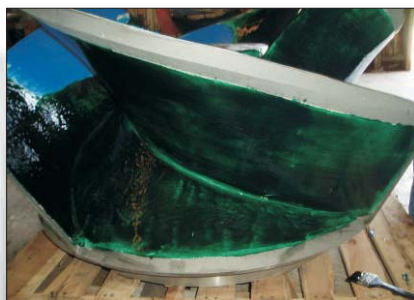
The stainless steel impeller of this large pump, located at a waste water treatment facility in Puerto Rico, was suffering from severe cavitation. The facility engineers needed a fast, reliable as well as cost-effective repair. The local ENECON Distributor was contacted to help find a solution.

It was decided that the impeller would first be prepared by grit blasting, followed by all cavitated areas being rebuilt with **DuraTough DP**.

The impeller was then protected from future cavitation damage with **DuraTough DL**.

In addition, **CeramAlloy CL+AC** was also used to protect the impeller's edges. **CeramAlloy CP+AC** and **CL+AC** were also used to rebuild and protect the pump casing which had significant corrosion damage.
