Focus on Flange Faces

After the successful repair to one of the two main condensers on the USS Austin (LPD-4) in Gibraltar, one of its sister ships - there are a total of 11 vessels in the Class - the USS Shreveport (LPD-12), was experiencing similar problems while stationed in Norfolk, Virginia.

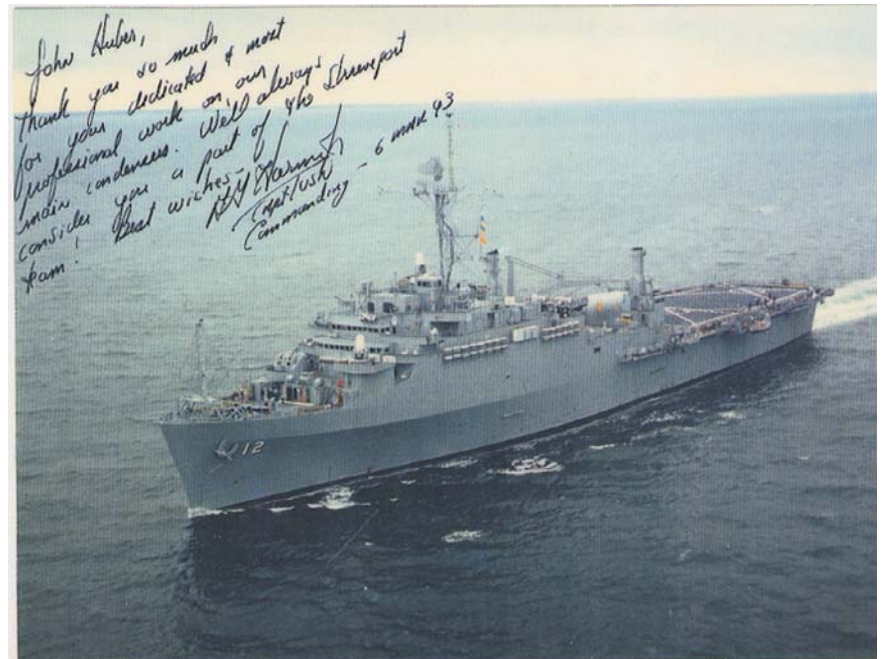
In this case, since there was more time available to carry out the repairs, both condensers were done with the ENECON CeramAlloy. The repairs were carried out using procedures "fine tuned" during the job on the Austin, including the rebuilding of the badly corroded flange faces of the water boxes.

After pulling the boxes, the damaged areas of the flange faces were thoroughly roughened using grinders to cut a coarse "hash marked" pattern in the surfaces.

Release Agent was used on the former to rebuild the corroded faces back to the proper shape.

After mixing the CeramAlloy CP+ and applying it to both the

roughened flange face and to the inside of the former, the former was positioned over the flange surface.

Using clamps to draw the former in and squeeze out the excess material, the flange face was rebuilt to the required size, shape and contour, thereby ensuring that the proper seal between the water box and the mating surface on the tube sheet could be achieved without the need for traditional, costly welding and machining procedures.

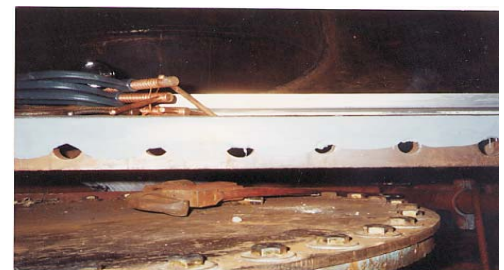
Smooth, ¼ inch thick aluminum angle coated with ENECON
