Oregon Paper Mill Repairs Damaged Chipper Disk With CeramAlloy... Savings Could Top \$100,000!

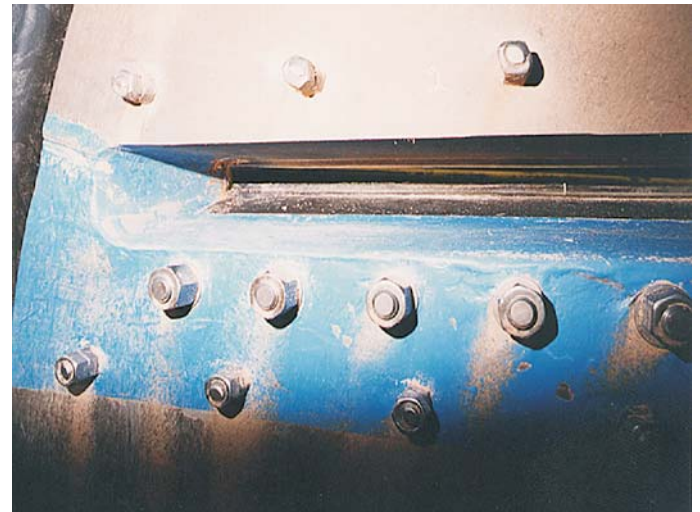
One year after repairs were made to all 8 pockets of a large (150+ inch diameter) chipper anvil, the enclosed photos were taken. The repairs involved rebuilding badly worn areas, which, if allowed to progress, would have threatened the structural integrity of the wheel. Replacement would have cost up to \$100,000 plus even more costly downtime

pocket had been eroded by about 2 inches, the shelf by $\frac{3}{4}$ inch, and the face by up to $\frac{1}{2}$ inch. Two kilograms of CeramAlloy CP+ were used to rebuild each pocket, followed by an overlay of CeramAlloy CL+ to protect the first eight inches of the face. Material costs were less than \$3,500, and labor consisted of two plant people, plus the ENECON Field Engineer, for 1-

In the pictures, wood residue shows as discoloration, especially on the face. The CL+ in those areas is virtually unaffected. The knives are changed daily by loosening the top two rows of studs with an impact wrench. The wrench has chipped pieces out of the face, but these do not progress beyond

the initial damage, and are not considered significant. Incidentally, the erosion is so severe that the steel nuts are worn round and must be replaced frequently!
