## California Refinery Reclaims Severely Damaged Salt Water Pump

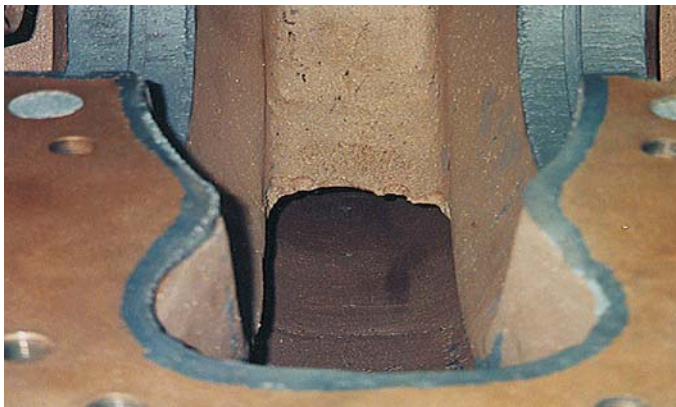
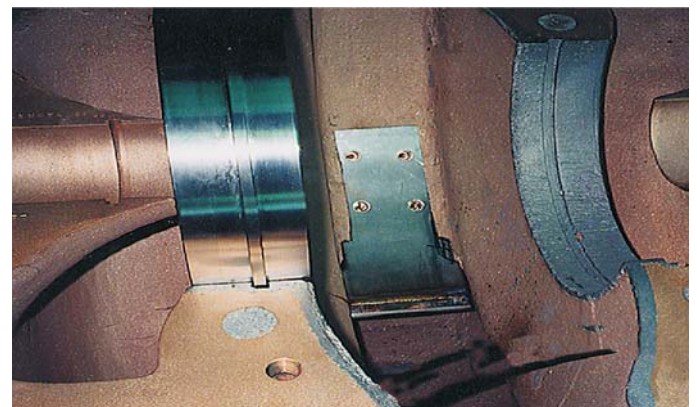
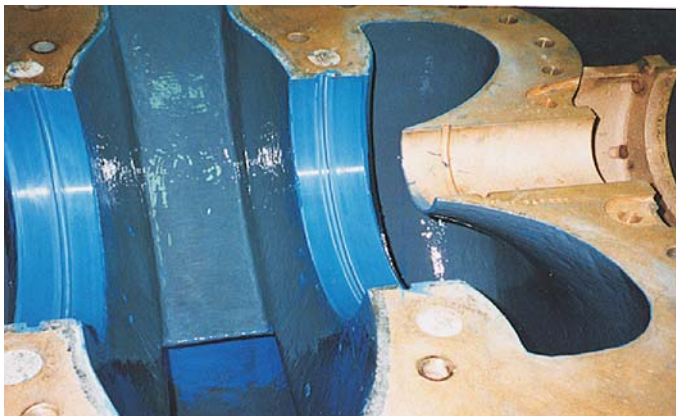
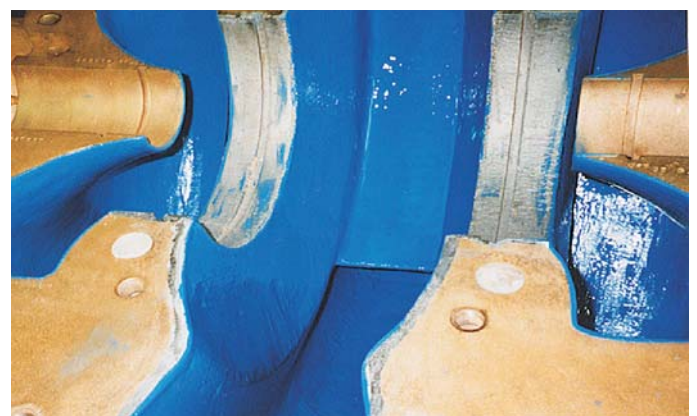
The cut water was found to be severely eroded. In addition, a previous coating in the pump had proven ineffective and was peeling off after being eroded and undercut by the seawater.

A new cut water was fabricated from stainless steel, and held

in place with CeramAlloy plus mechanical fasteners. All wet areas were then rebuilt and coated with the CeramAlloy system.

The CeramAlloy was also used to rebuild the ring seats - creating a perfect fit with the new rings - **without the need for machining.**
