## U.S. Navy Salvages Main Salt Water Circulating Pump on an Amphibious Assault Ship with CeramAlloy

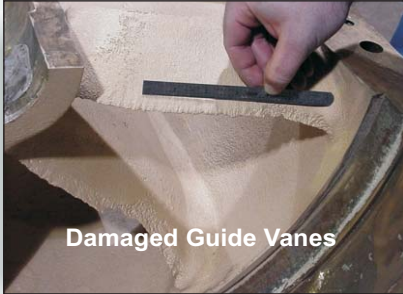
Damaged Guide Vanes

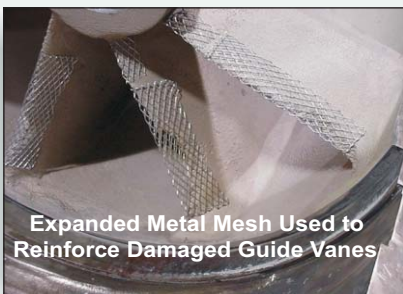
Expanded Metal Mesh Used to Reinforce Damaged Guide Vanes

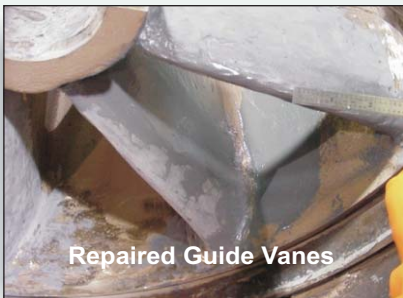
Repaired Guide Vanes

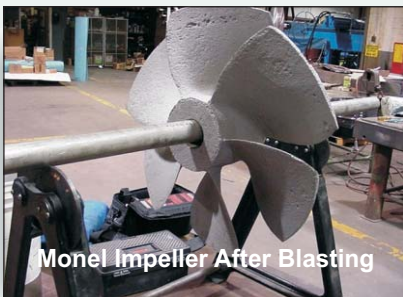
Monel Impeller After Blasting

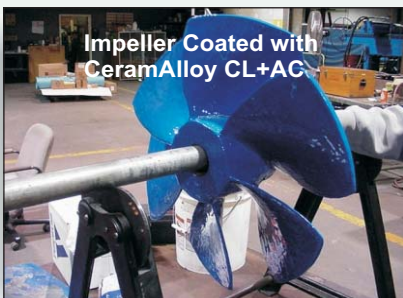
Impeller Coated with CeramAlloy CL+AC

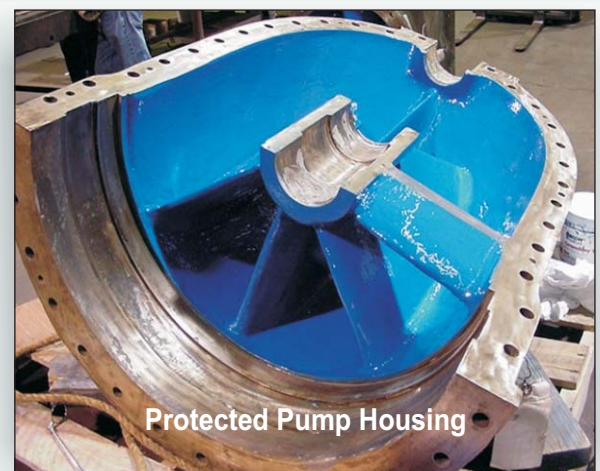
Protected Pump Housing
