## New York City Office Building Saves 16 Inch Refrigeration Pipe with METALCLAD DuraWrap

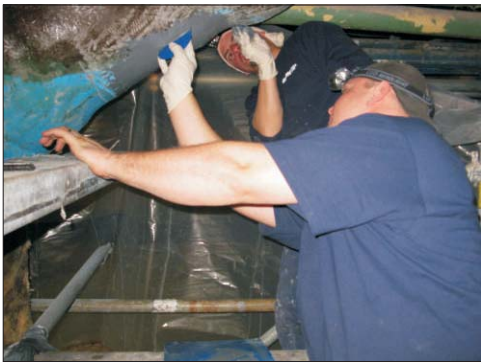
This 16 inch fiberglass condenser discharge pipe, located in a large office building in lower Manhattan, developed a leak where the line joined the main header running just under the ceiling.

The leak had developed near an older repair close to the 'Y' connection on the header. Since the building provides cooling all year round, it does not have the luxury of shutting down its chillers to take the pipe out of service for an extended period of time.
