CHEMCLAD XC “Cures” Shower Stall Problems at New Jersey Hospital

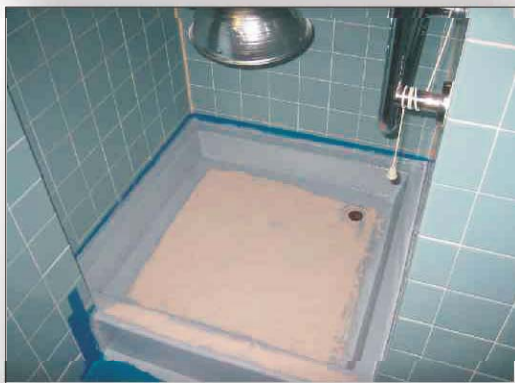
Heat lamps were used to accelerate the cure of the first layer of CHEMCLAD XC

A first layer of CHEMCLAD XC was applied by brush and roller. An anti-slip aggregate was broadcast into the uncured CHEMCLAD XC. This filled in pits in the concrete surface and improved the safety of the showers. After sweeping up the excess aggregate, a second layer of CHEMCLAD XC in the finished color was applied.

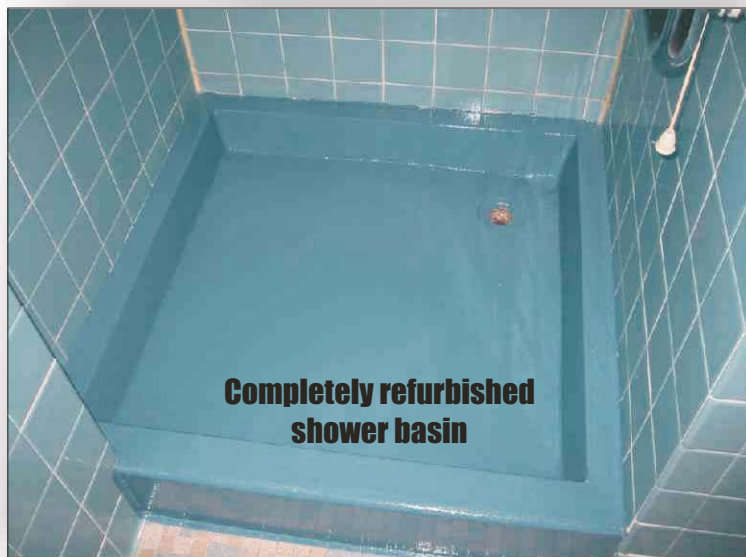
The finished basins have an easy-to-clean and safe “diving board” finish. Over 80 showers have received this treatment.
