CHEMCLAD SC & DurAlloy Solve Corrosion Problems at Indonesian Plant

The local ENECON Dealer located in North Sumatera Island in Indonesia was asked to provide a commercially proven, cost effective solution for this condenser pump repair and protection project at a state owned power station.

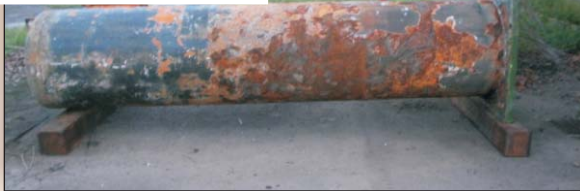
Note the blistering & under-film corrosion of the conventional epoxy paint system

pieces as illustrated in these photos.

The existing epoxy coating had failed badly and under-film corrosion was destroying the spool

The repair procedure included thorough grit blasting of the metal. All deeply pitted and damaged areas were then re-built with METALCLAD DurAlloy and sanded smooth.

Two coats of CHEMCLAD SC were then applied to provide long-term protection to these pump sections.

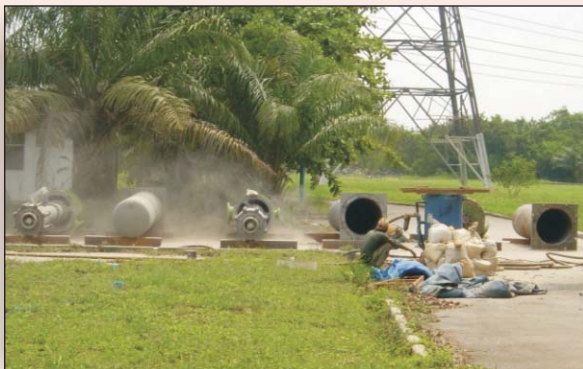
All pump sections were grit blasted.

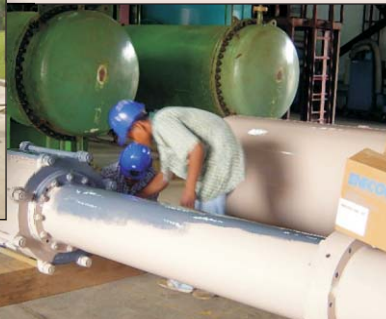
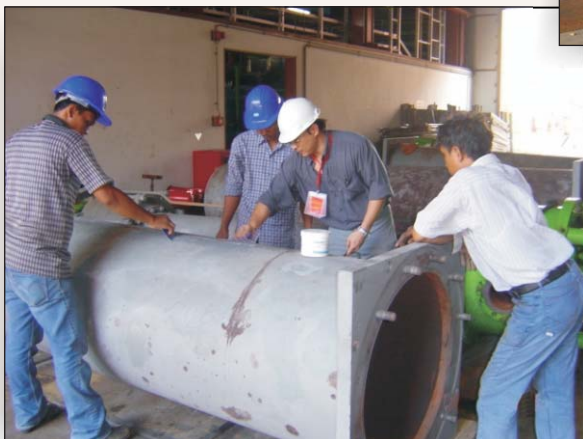
DurAlloy being applied to repair pitted areas.

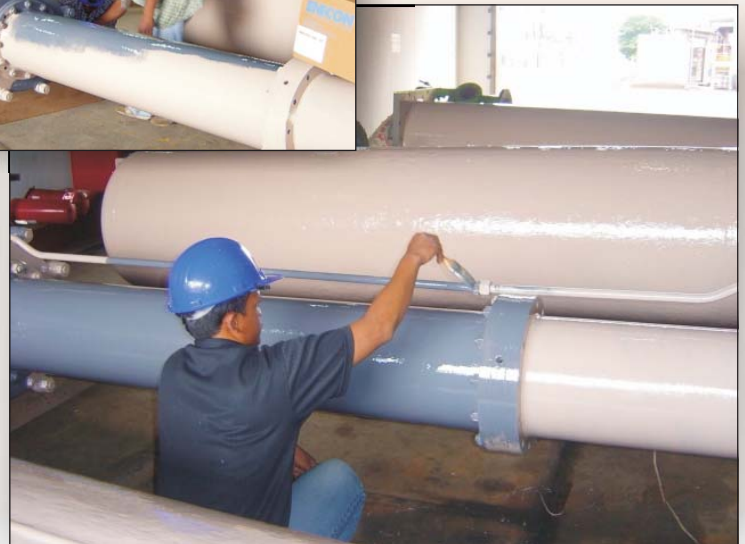
Final coat of CHEMCLAD SC being applied.
