## ENECON Partners With Local Mechanical Engineering Company To Repair & Protect Cooling Tower

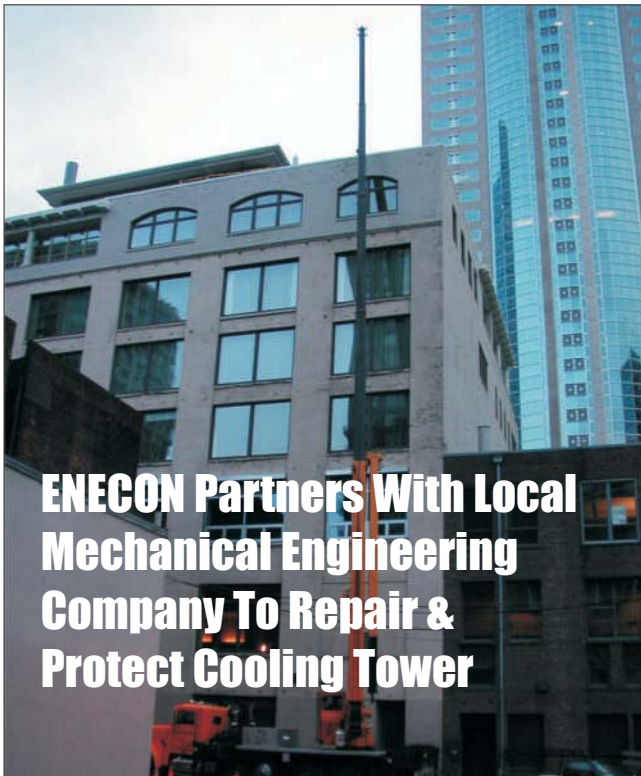
This 25 year old cooling tower located in downtown Seattle was built inside a structure with steel beams and a roof above it making it a very difficult candidate for replacement without involving major structural demolition and rebuilding.

The interior of this cooling tower was grit blasted. The doubler plates were adhered in place then faired with DurAlloy. Two coats of CHEMCLAD SC were then applied. The fan shroud was coated separately with ENESEAL CR.

A local mechanical engineering company replaced the fill, strainers, nozzles, shaft, bearings, as well as fabricated and installed several new stainless steel replacement pieces.
