DuraQuartz

Keeps the Mail Moving at Postal Center

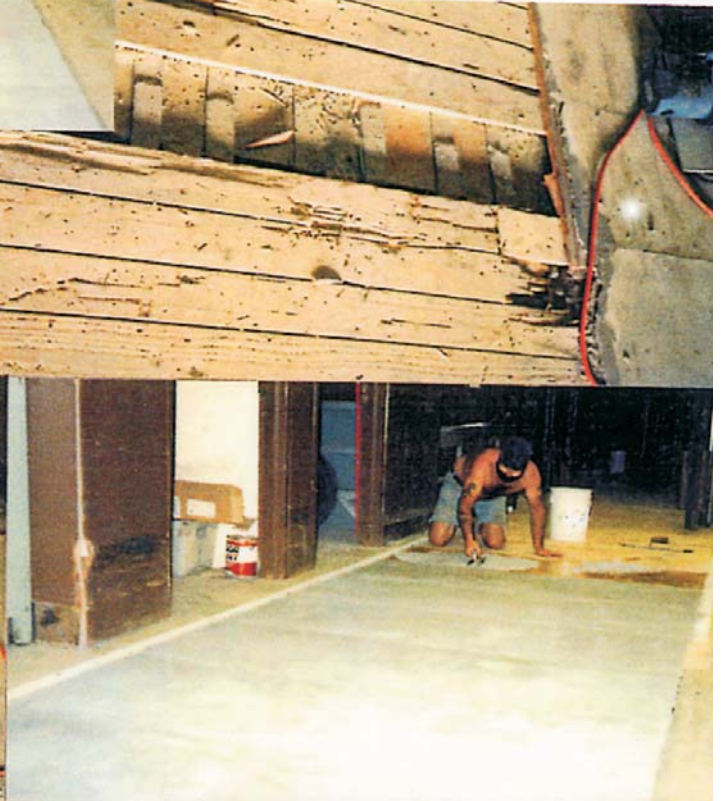
John Huber, ENECON North East's Senior Field Engineer, received a call to solve a difficult floor problem at a U.S. Post Office on Long Island, New York. Repeated attempts to repair the floor in a loading area proved futile due to the wear and abuse the floor sustains from heavily loaded, steel wheeled mail carts. Every repair that was tried provided only limited performance.

John recommended a 1/4 inch DuraQuartz "pad" installation over new 3/4 inch plywood decking.

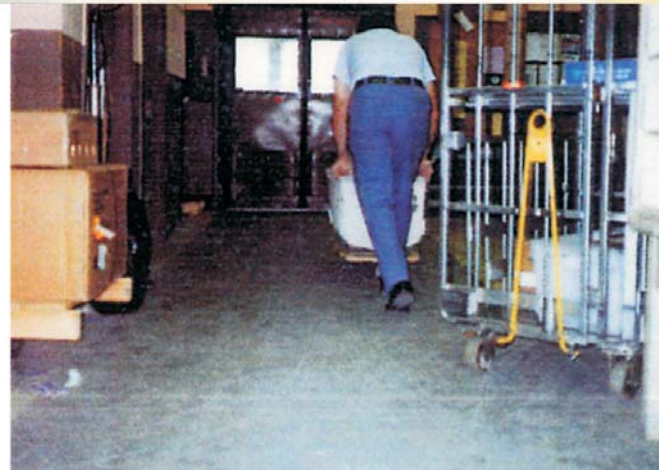
DuraQuartz providing years of trouble-free performance at Postal Center loading area.

The application was completed by a local contractor under John's careful supervision and has now given trouble-free performance at the Post Office for years. And once again, neither rain nor sleet nor hail, nor difficult floor problems...
