DuraQuartz & CHEMCLAD XC Seal Leaks In Hospital Kitchen Floor

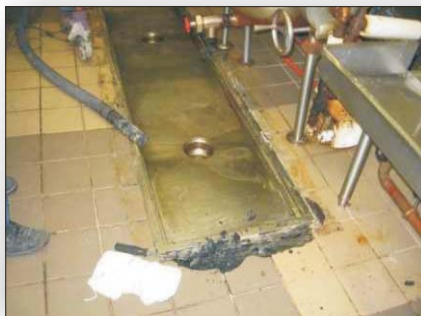
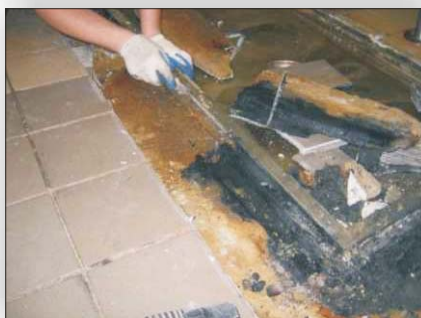
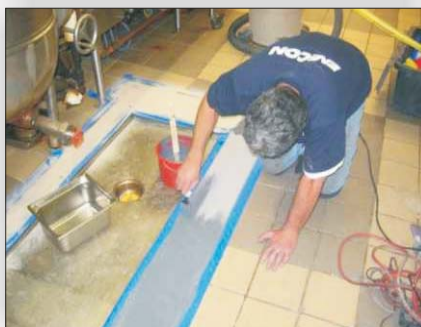
The first course of tile around the trough was carefully removed and the true source of the problem was revealed. The underlying thin set mortar and concrete was severely deteriorated by water and food acids.

After damaged materials were removed, DuraQuartz was applied to provide a smooth transition from the quarry tile floor to the rim of the trough.
