ENECRETE & ENESEAL Bring Degrading Hospital Staircase 'Back to Life'

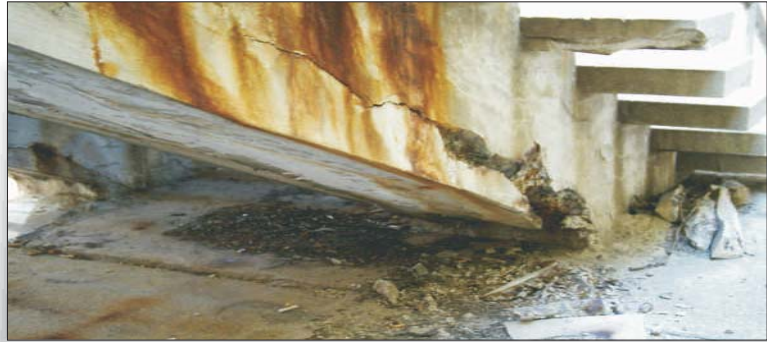
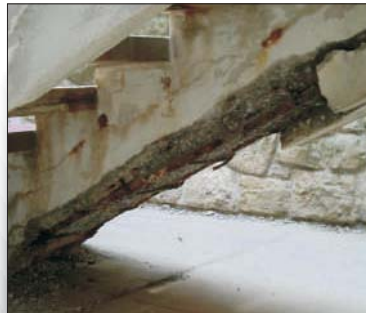
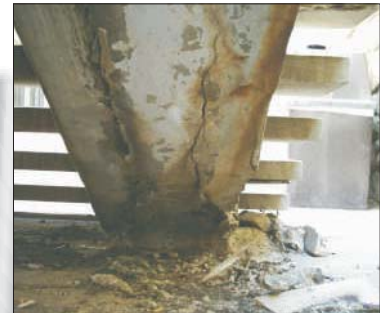
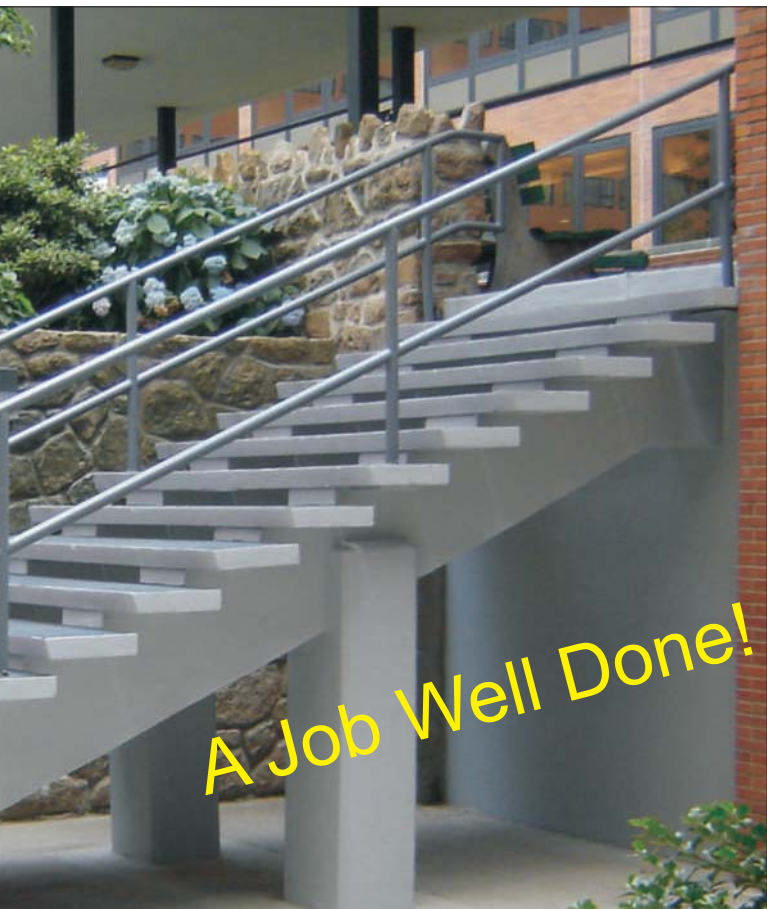
This prestigious medical center located in the Northeastern U.S. had a severe problem with their main entry steps. Replacing them was not an option as they were an important part of the hospital's classic 1950's style of architecture.

After determining that the steps were structurally sound and not a danger to the public, the hospital's engineers then needed to find a cost effective, viable repair and protection system. The local ENECON Engineering Specialist was contacted.

He recommended that a combination of *ENECRETE DuraQuartz* and *DuraFill* as well as *ENESEAL CR* be used over a 5 day period to repair and protect these steps.

After thoroughly cleaning the substrate, *DuraQuartz* was first used to rebuild the deteriorating stair structure.

ENESEAL CR was then used to protect the concrete from further corrosion as well as create a uniform look. *DuraFill* was then used on the top of the step surfaces to provide a slip-resistant safety surface.
