DuraQuartz Repairs Concrete Slab at Costa Rican Beer Manufacturer

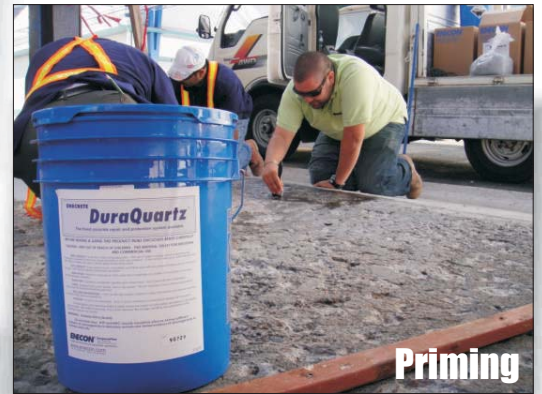
Priming
