## Power Station Solves Nagging Leakage Problem With ENESEAL HR

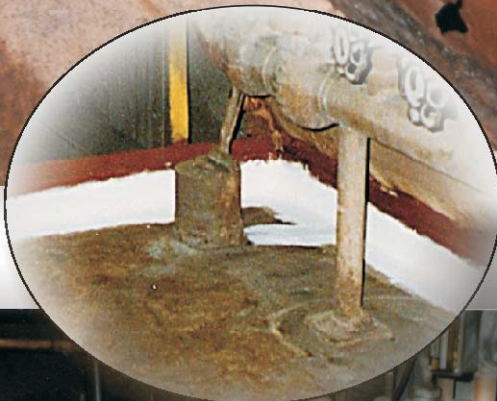
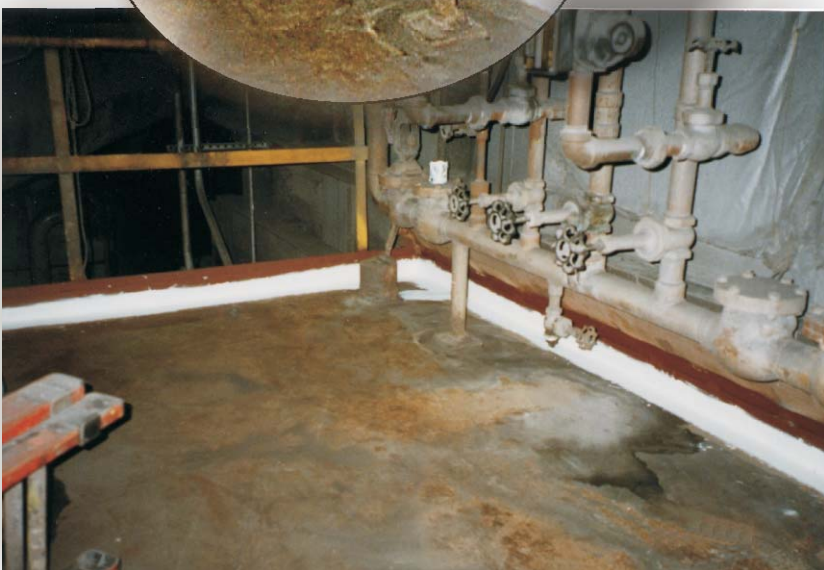
A concrete deck area - bordered by a metal curb - was subject to liquids splashing and collecting around the edges.

In addition, time - and corrosion - had made holes in the metal edging, making continuing such attempts futile.

After preparing the surfaces and priming the steel, the ENECON Field Engineer used polyethylene tape to "bridge" the gap and create a smooth transition between the curb and the floor.

Then, using fiberglass mesh to reinforce the repair, the **ENESEAL HR** was brushed on to completely seal the joint and prevent further leakage.
