ENESEAL HR Solves Leaking Hangar Problems at Indian Airport

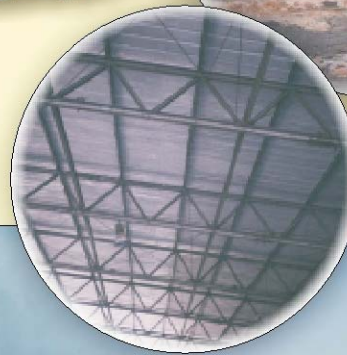
After

Just two days after the application was finished, torrential rains buffeted the city. To the amazement of the airport engineers, the ENESEAL coated roofs were completely water-tight. They are now in the process of tackling other problem roof areas at the airport.

All roof surfaces were cleaned and a rust “converter” was used to treat rusted areas. Fiberglass reinforcing mesh was used to bridge holes in the roof with ENESEAL. Two additional coats of ENESEAL HR were then applied to completely seal the entire roof area. The project was completed in about 80 days – well ahead of the stipulated 90 day schedule.
