## ENESEAL CR & HR Rescue Port Authority Roof in the Philippines

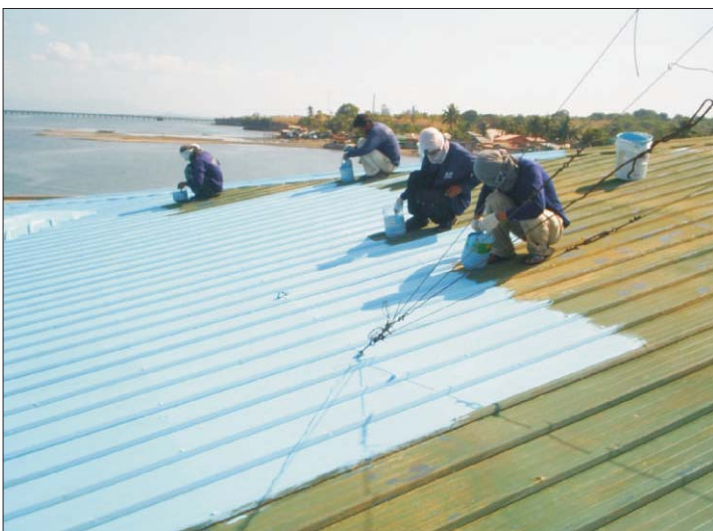
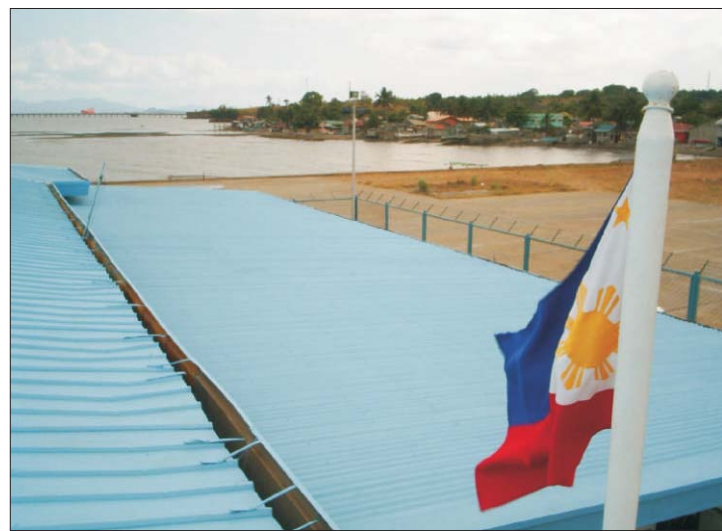
This metal roof of an administration building in a local Port Authority in the Philippines had deteriorated severely due to the harsh marine environment. The foam insulation material that had been applied only 4 years ago was in very poor shape.

After stripping off the foam insulation, the entire roof was then pressure washed and inspected for holes in the metal structure. These were repaired with DurAlloy and reinforcement tape or

metal patches secured with DurAlloy. Any open seams were caulked and sealed.

**ENESEAL CR** (tinted blue) was then applied over the entire roof area to provide long-term corrosion protection followed by **ENESEAL HR** (also tinted blue) to provide a heat refractive surface. **Problem solved - quickly and cost effectively!**
