## **CeramAlloy Used for Critical Pump Repairs At Nuclear Station... Saves \$90,000 in Replacement Costs!**

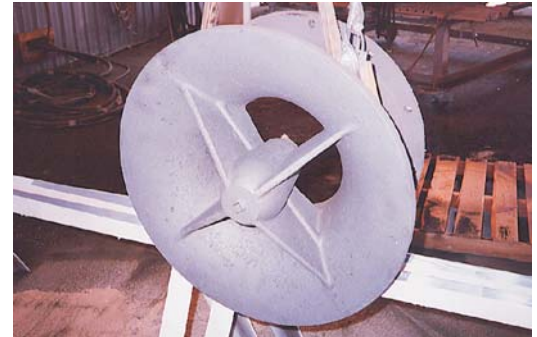
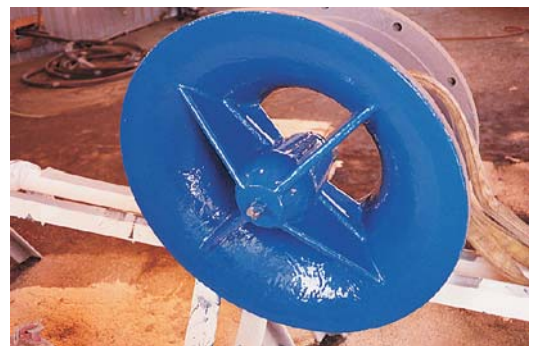
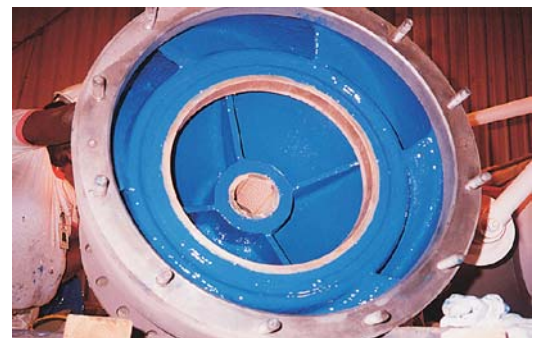
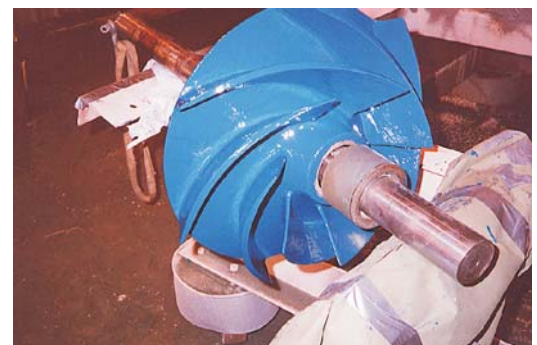
The plant engineers at a nuclear power station located in the Pacific Northwest in the US discovered severe erosion/corrosion wear on the impeller, the suction bell and the diffuser bowl of a large submersible pump. This tower make-up water pump supplies water from the river to the cooling towers.

Sand and silt entrained in the river water accelerated the erosion damage to the pump while electrolysis problems had also accelerated the corrosion damage.

All the pump components were first abrasive blasted to a 3-4 mil profile. All pitted areas on the diffuser bowl and the suction bell were then filled using CeramAlloy CP+ followed by the application of two coats of CeramAlloy CL+. The impeller, due to the rough surface, was coated with brush-applied CP+ to fill in as a base for the subsequent two coats of CL+.
