Super Job on this Super Titan

ENECON's Australian Engineering Team came across this Super Titan pump at one of the largest copper mines in the world.

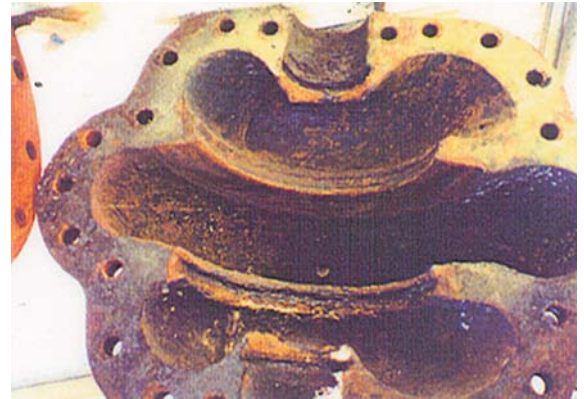
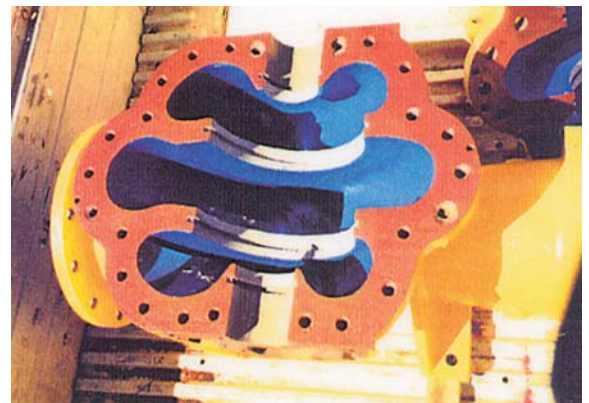
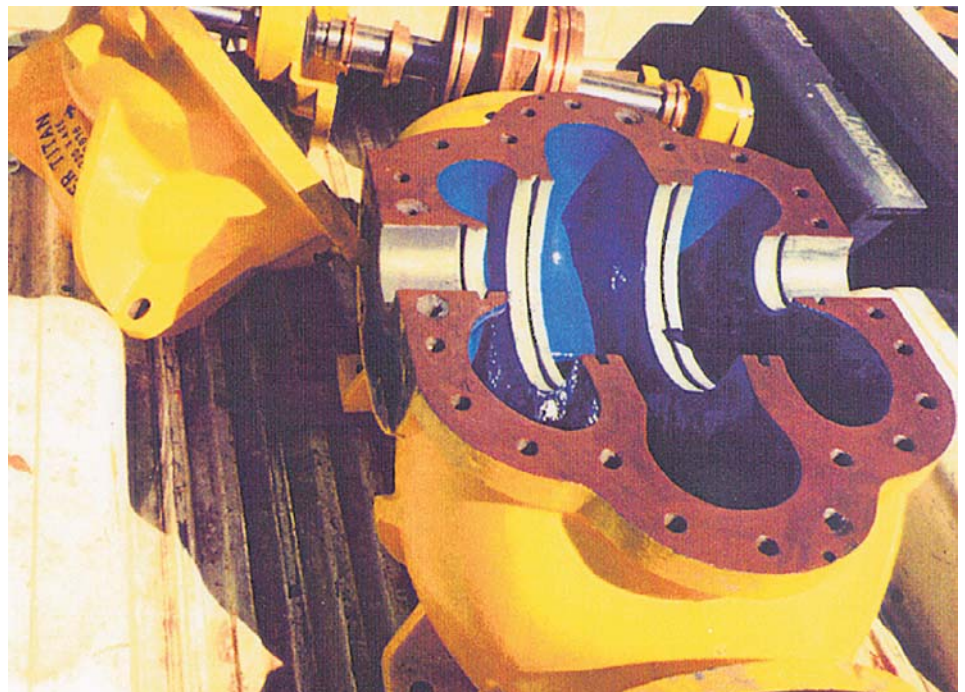
Severe erosion and corrosion from copper sulfate had taken its toll. So much so, in fact, that this **\$20,000 casing** was found in the **scrap heap!**

The photos clearly show the "**picture perfect**" results. And, the total cost of rebuilding - including multiple blastings, all labor, materials, reassembly, etc. - was **less than 25% of the replacement cost of the casing!**

The level of ingrained contaminant required grit blasting and "leaching" the casing **6 times** prior to any materials being applied. The wear ring areas required build-ups of 10 to 15 mm (about one-half inch) using **CP+**. Tolerances were especially critical since the plant required a running clearance of 0.005".

All the "wet areas" were then treated with **CeramAlloy CL+** to completely protect the casing from the accelerated attack it will be subjected to when returned to service.
