CeramAlloy Gives New Life to Extinct Valve

This sea water valve from a ZIM Line vessel was desperately in need of replacement. However, these valves were not available any more and "replacement" was no longer a viable solution.

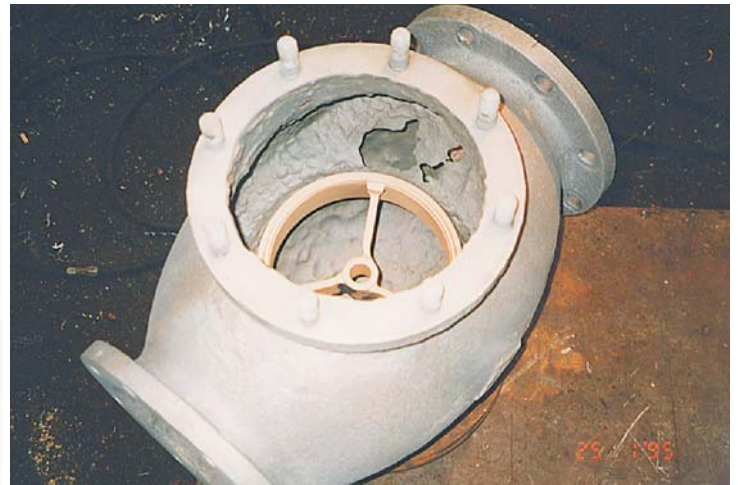
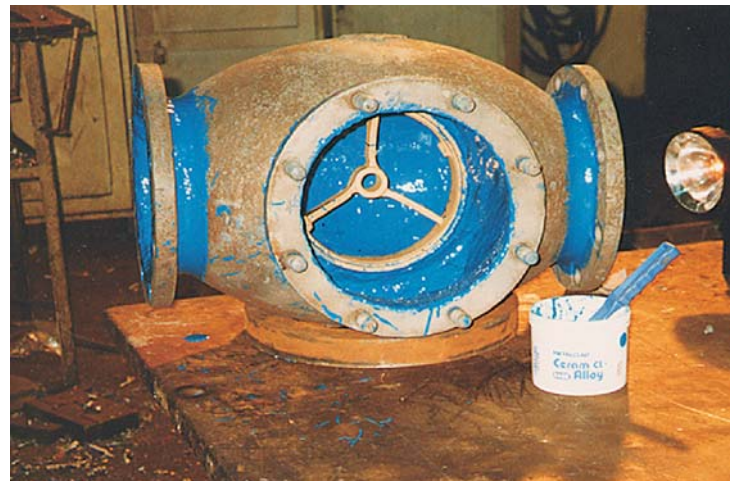
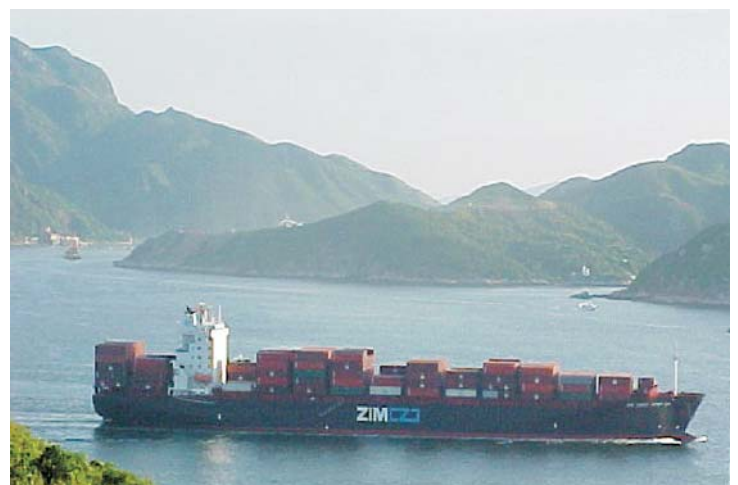
After first grit blasting the valve, the holed areas were rebuilt using METALCLAD DurAlloy

and Reinforcement Tape. After only 20 minutes, the entire inside of the valve was rebuilt with CeramAlloy CP+. All internal (wet) areas were then coated with CeramAlloy CL+ to complete the repair.

The entire project took only part of a day to complete and was carried out in the Shipyard. On the following day, the ship inspector conducted a pressure test on the valve. Although normally requiring a pressure of 2 atmospheres in such testing, **the rebuilt valve was taken to 6 atmospheres and the results were perfect!**
