## \$300,000 Repair Project Completed at Major Northeastern Utility. 40-Year Old Cast Iron Water Boxes & Tube Sheets Repaired & Protected With CeramAlloy.

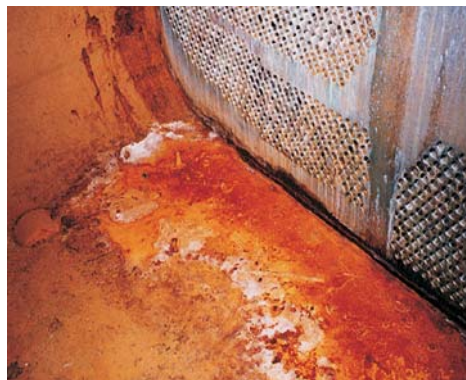
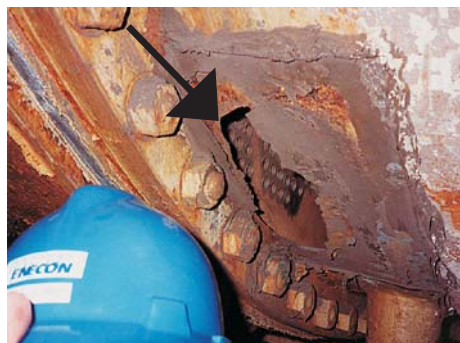
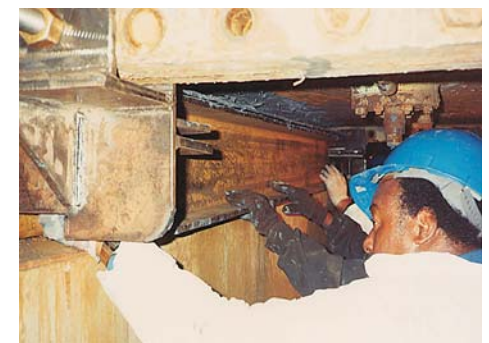
The cast iron water boxes were so severely damaged that huge holes, exposed during grit blasting, had to be repaired using steel plates and girders bonded and sealed with CeramAlloy.

A total of 8 cast iron water boxes which were built in the 1950's plus 8 tube sheets were repaired, rebuilt and resurfaced with **ENECON CeramAlloy**
