## Pennsylvania Power Station Solves Severe Erosion/Corrosion Damage on Generator Cooler With CeramAlloy

A local ENECON Fluid Flow Systems Specialist based in the Pittsburgh area supervised the repair and refurbishment of an **Alterex Cooler** at a major power station in Western Pennsylvania.

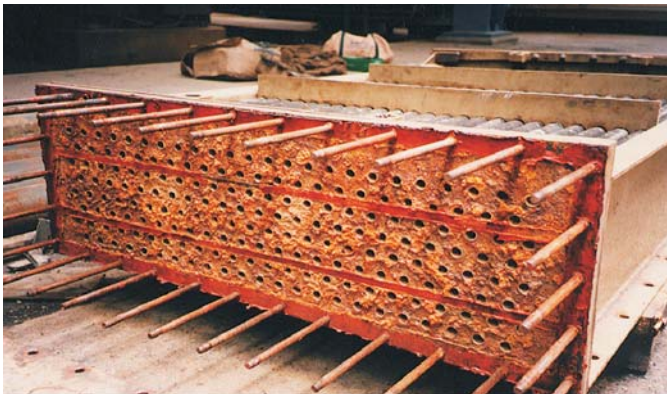
GE generators at the plant so when the extent of the erosion and corrosion damage to the cooler was discovered, a rapid repair procedure became very important.

*The severely damaged cooler.*

project which included thorough grit blasting and installing a ¼ inch thick build-up of CeramAlloy CP+ followed by a coat of CeramAlloy CL+ to provide a smooth finish to the tubesheet.

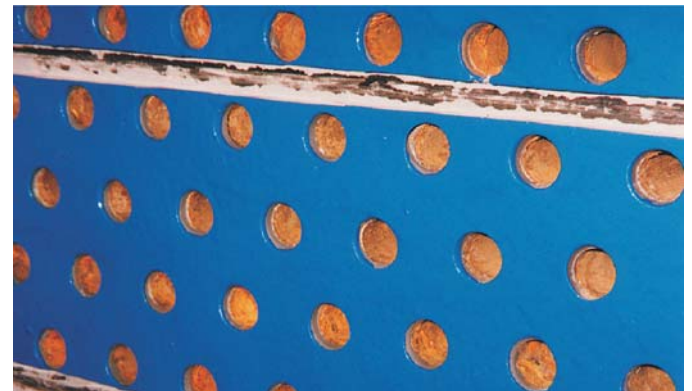
*CeramAlloy CL+ applied to complete the project.*
