## Badly Worn & Holed Pump Casing at Major Paper Mill Repaired & Resurfaced With CeramAlloy

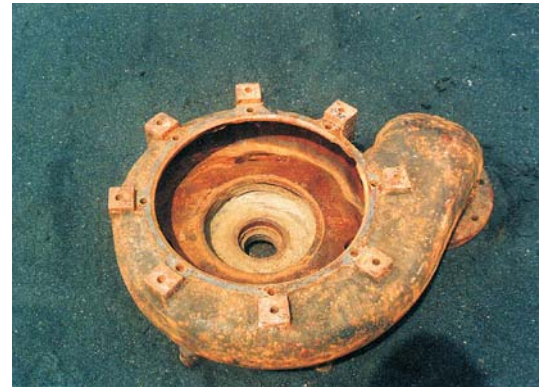
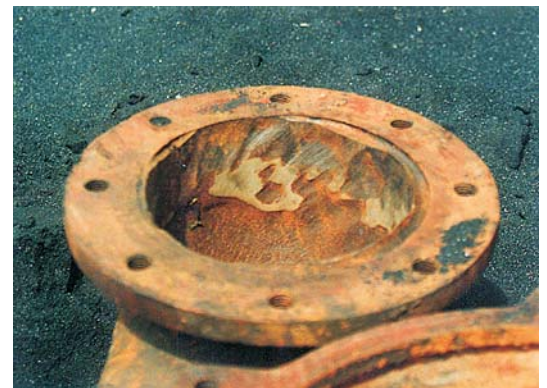
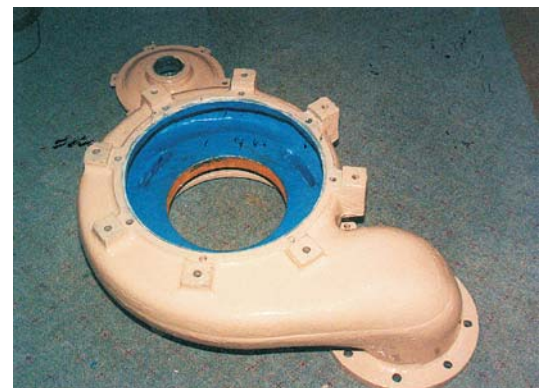
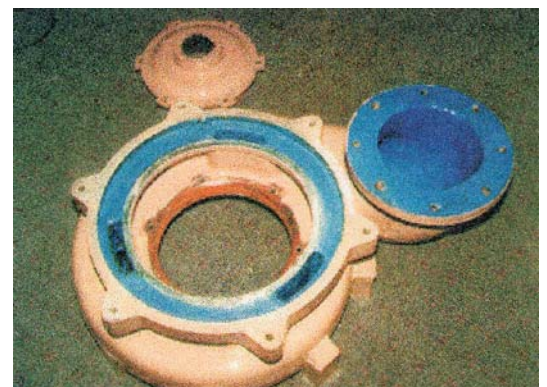
The plant engineers at a major pulp and paper mill in South Africa discovered a severe erosion and corrosion problem on their pump.

After thorough grit blasting, all eroded and holed areas were first rebuilt with CeramAlloy CP+, and then two coats of CeramAlloy CL+ liquid ceramic were applied to all wet

areas in order to protect the pump from future erosion/corrosion attack.
