UK Refinery - One of the Largest in Europe - Salvages Badly Eroded/Corroded Pump With CeramAlloy & DuraTough

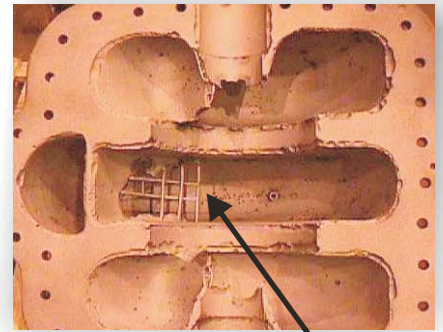
At this huge refinery in the United Kingdom, this severely damaged pump casing was ready for the scrap heap. However, Graham Wilson, the local ENECON Distributor, convinced the plant engineers to rebuild this

Note the severe damage...

large pump casing and impeller with ENECON CeramAlloy and DuraTough High Performance Polymer composites. Since it was determined that a significant cause of the damage to the guide

vanes (cutwaters) and impeller was cavitation attack, DuraTough was selected to be used in conjunction with the CeramAlloy on the guide vanes and impeller for added protection.

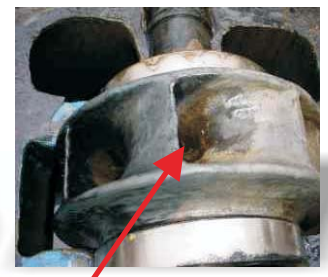
Inspected after 9 months in service, the rebuilt pump was shown to be in excellent shape and continues to perform perfectly.

The pump impeller and bottom casing after 9 months continuous duty, showing the DuraTough DL protection of the impeller surface is still in good condition.
