U.S. Aircraft Carrier Seals Leaking Hatches on Flight Deck

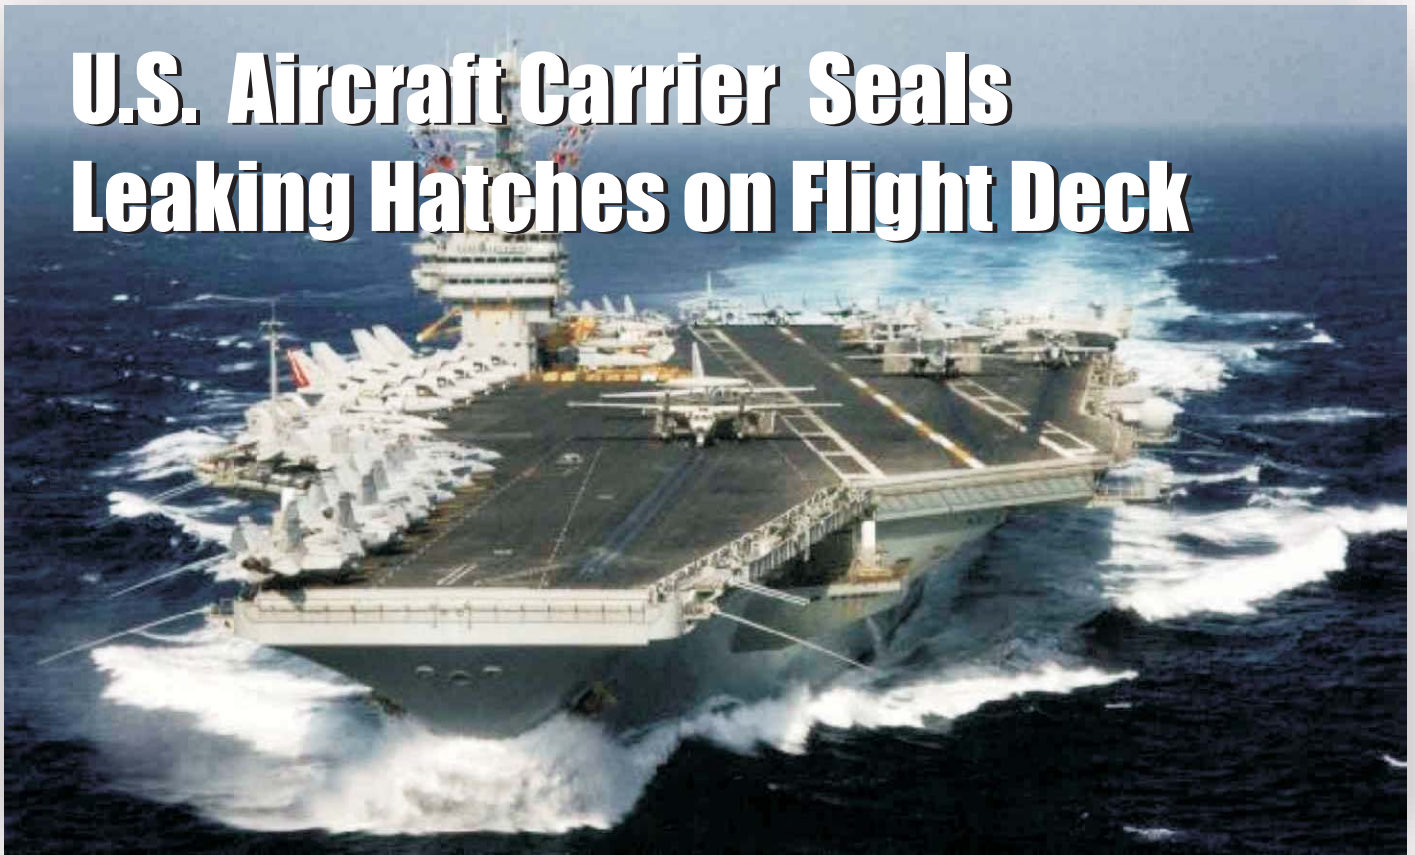
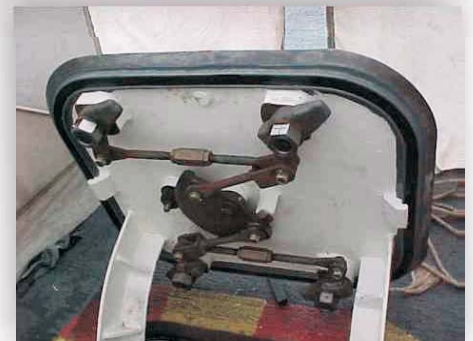
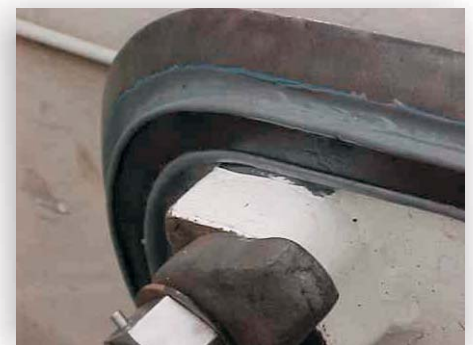
The Auxiliary Electric Start Systems (AESS) lockers on an aircraft carrier provide the ability to “jump start” a fighter plane if required. The hatches are flush with the carrier deck and are designed to keep water and other contaminants from getting into these lockers – potentially compromising the operation of the electrical systems.

What often happens, however, is the gasket retainer corrodes due to constant immersion in saltwater, fuel, hydraulic fluid, etc. As a result, the hatches leak and the AESS lockers can fill with water. This is not a good thing.

A conventional welding repair is time-consuming and sometimes damages the hatches. The ship’s engineers decided to utilize a

more “high-tech” approach. The damaged areas were repaired with DurAlloy then sanded smooth to the desired shape and dimension. Two coats of CeramAlloy CL+ [AC] were then applied over the entire seal area to provide long-term corrosion protection to these hatches.
