## Largest US Gold Producer Repairs Heat Exchanger With CeramAlloy

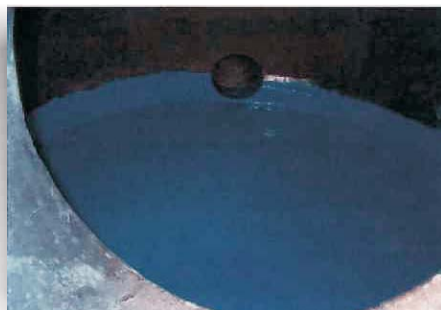
Water box repaired & coated

the situation and recommended a standard high-build CeramAlloy cladding system to rebuild and protect the 9-foot diameter, lead tube sheet and the steel water box.

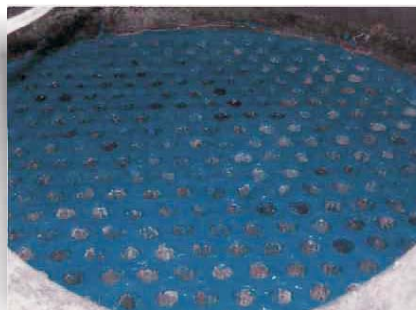
Tube sheet repaired & protected
