Spanish Nuclear Station Chooses CeramAlloy & DuraQuartz To Control Corrosion On Cooling Water Intake Lines

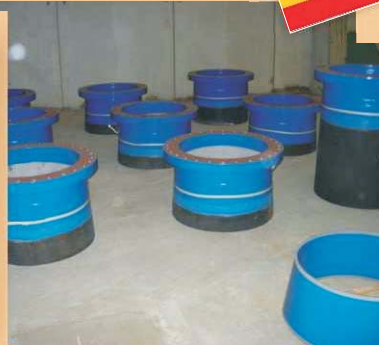
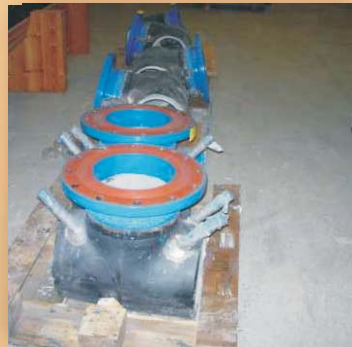
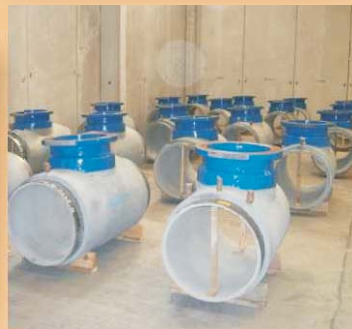
The maintenance engineers of this major nuclear power station were experiencing problems in their cooling water intake lines due to ineffective seals on the access manhole collars. The metal intake piping is encased in concrete and the existing design was allowing water to seep between the concrete shell and the metal core. This caused corrosion on the outside of the metal pipe.

The local ENECON Ibérica specialist recommended building up the joint between the metal collars and the concrete casing with DuraQuartz to prevent the water from getting behind the seal. After the DuraQuartz was applied, the collars were coated with two layers of CeramAlloy CL+(AC) to complete the application.

Upon reassembly, the station engineers were completely pleased when they saw that the leakage had been stopped and the corrosion problem eliminated.
