## Major International Chemical Company Turns to ENECON for Help in Solving Serious Corrosion Issues

This 20-year-old preheater located at a soda ash manufacturing plant in India had been suffering from severe chemical attack and erosion damage.

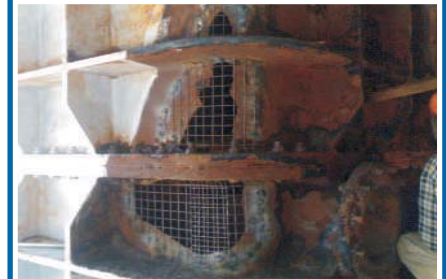
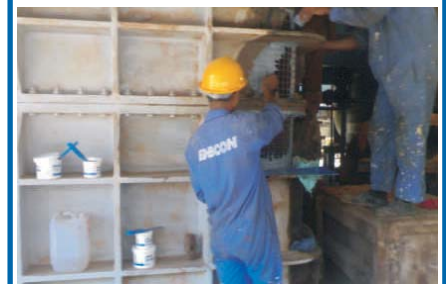
When the surfaces were grit blasted, large holes in the steel were uncovered and these had to be repaired immediately. Welding was not possible due to the potential for further damage to the thin metal surfaces. The ENECON field engineers, therefore, recommended an unconventional repair procedure: stainless steel wire mesh was used to bridge the large holes in the steelwork and **DurAlloy** (224 kg.) was used to permanently repair these areas.

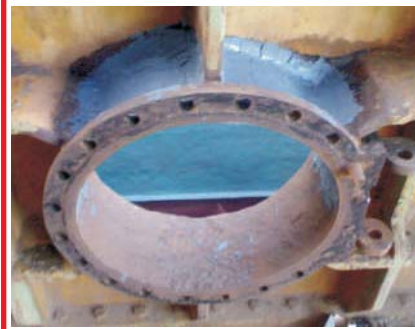
After all holes were repaired, 2 coats of **ENESEAL CR** (280 kg.) were used to protect all of the exterior surfaces from the aggressive environment at this facility.

The plant's management was extremely satisfied with the outcome of this project. This preheater was put back into service immediately and preparations are being made to repeat this repair/protection project on another of the plant's preheaters.
