CeramAlloy CBX Outperforms Rubber Liner & Hardface Welding

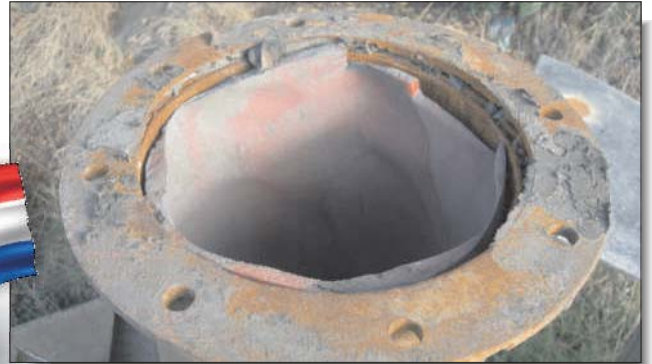
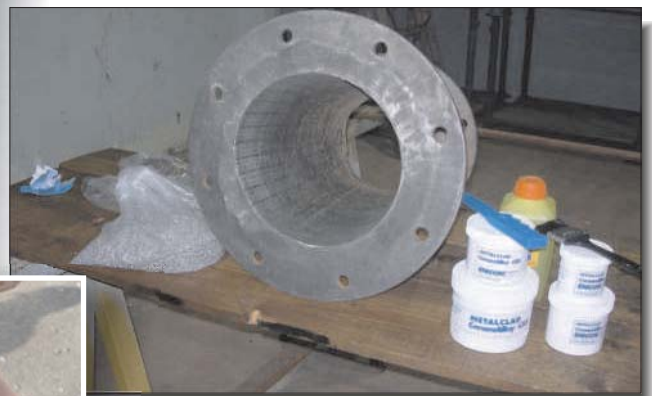
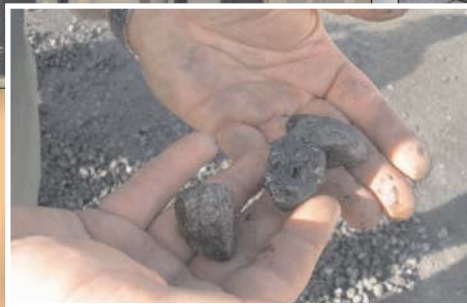
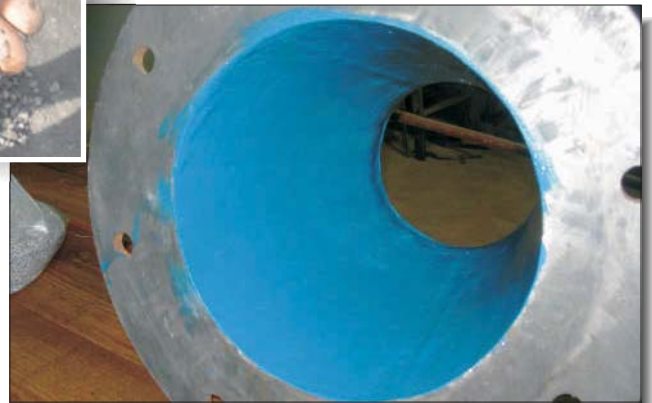
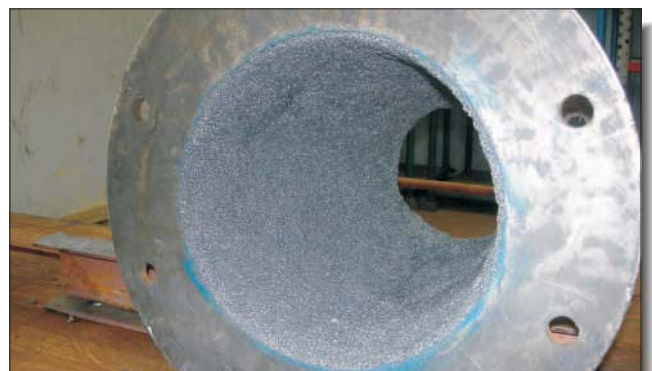
A local municipality on the Adriatic Sea in Croatia wanted to move a welding manufacturing plant from its seaside location to another site further inland. However, as part of this move, they were required to dispose of thousands of tons of slag which contained Silicon Manganese and Ferro Manganese, both of which have high re-sale values when separated. In order to do this effectively, these two metallic materials needed to be separated from the slag through cyclone separators - which typically must be repaired every month.

The plant engineers wanted to see if they could find a more durable repair material so they conducted a side-by-side test utilizing a rubber liner for one

cyclone, hardface welding on another and CeramAlloy CBX on a third cyclone.

After three weeks the rubber liner and the hard-facing had both failed but the CBX was still providing excellent protection. The engineers selected our CBX as their standard repair material for this demanding application and immediately coated three additional spare cyclones.
