Waste Water Treatment Facility Saves Main Sewage Pipe

This 96 inch raw sewage force main, located at a waste water treatment facility in the Northeastern United States, had been eroded internally due to years in service.

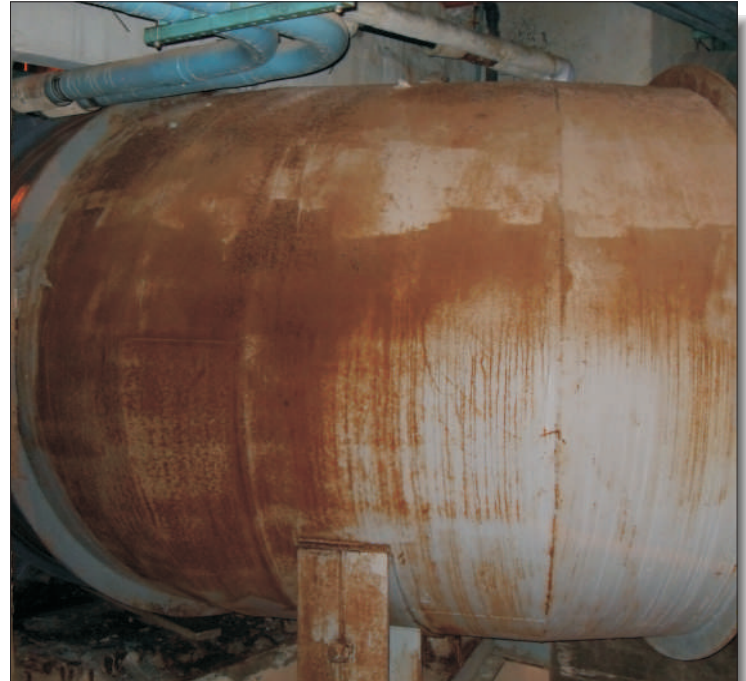
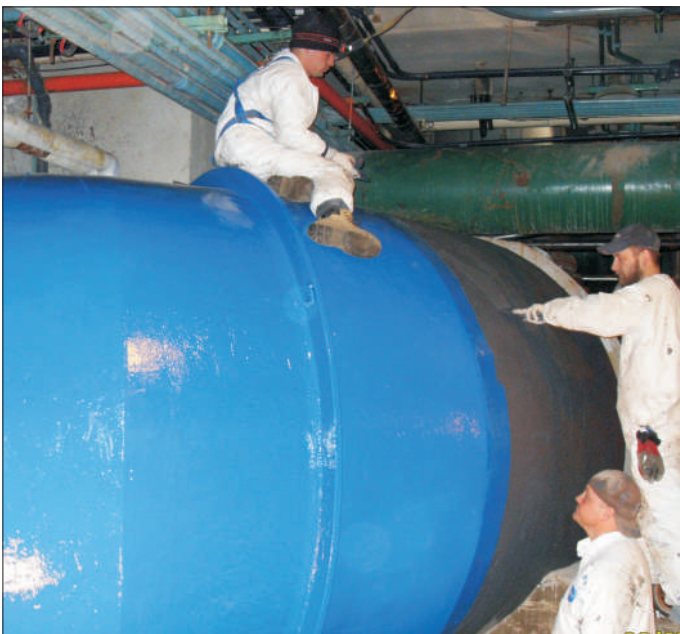
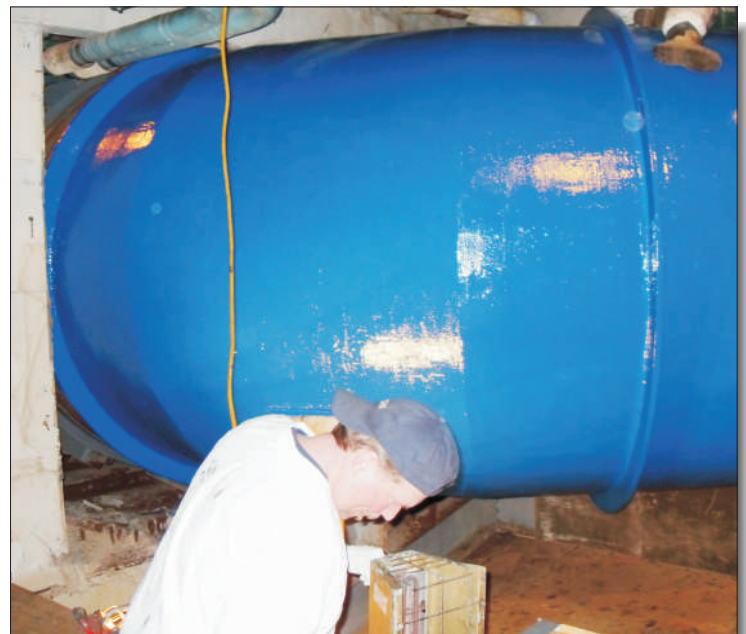
Faced with the threat of leaking raw sewage, the plant engineers contacted their local ENECON Field Engineer to provide a solution. After careful inspection, as much as 1/3 of the pipe's thickness in some places had been lost to erosion.

Fearful that grit blasting may cause further damage, the pipes were roughened mechanically.

An application of **CeramAlloy CP+AC** and **CeramAlloy CL+AC** was carried out followed by a wrapped layer of fiberglass mesh to reinforce the repair and enhance the pipe's structural integrity. A second application of **CeramAlloy CP+AC** and **CeramAlloy CL+AC** was then applied to complete the repair.
