DurAlloy & ENESEAL CR Salvage Fume Extraction System at Canadian Steel Mill Saving \$100k & Reducing Emissions

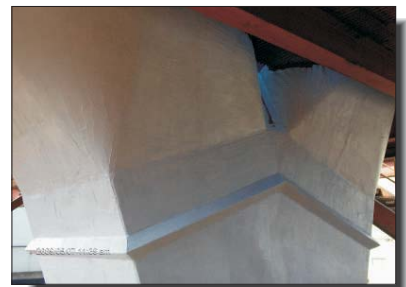
DurAlloy applied over entire extractor shell.

DurAlloy. As a final measure the unit was coated with **ENESEAL CR** for optimum corrosion resistance and a uniform look.

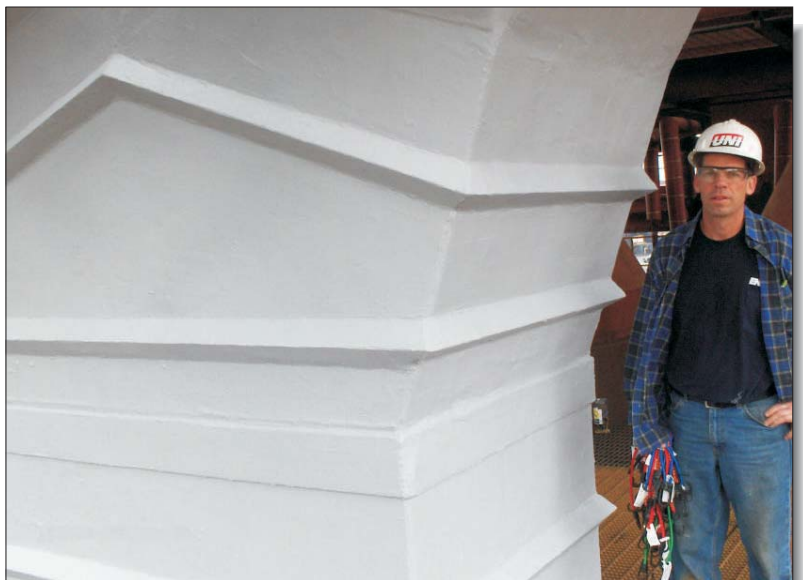
After totally encapsulating the unit in DurAlloy, ENESEAL CR was used to provide optimum corrosion resistance and a uniform look.
