DuraWrap Carbon Fiber Pipe Wrap System Saves Tennessee Municipality Thousands of Dollars

Leaky sewage discharge pipe elbow joints, located at a waste water treatment facility in Tennessee, can cost up to \$100,000 and several days of down time to replace after failure.

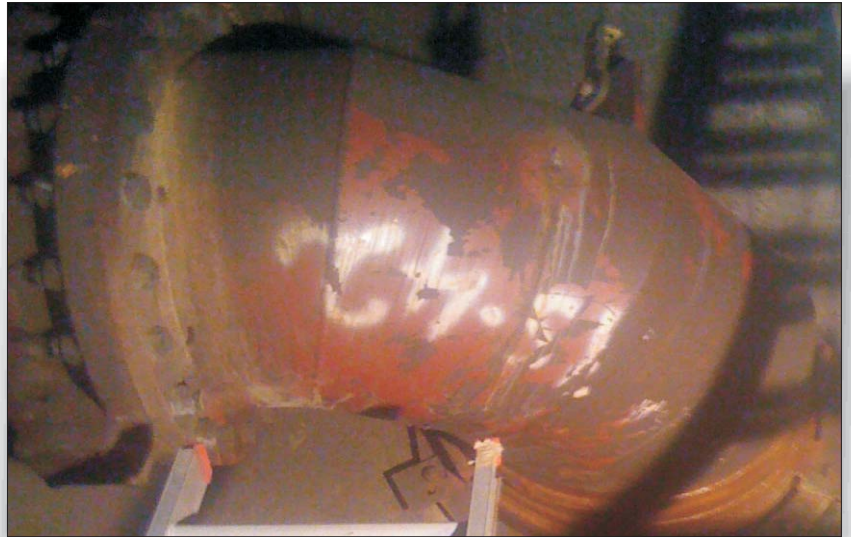
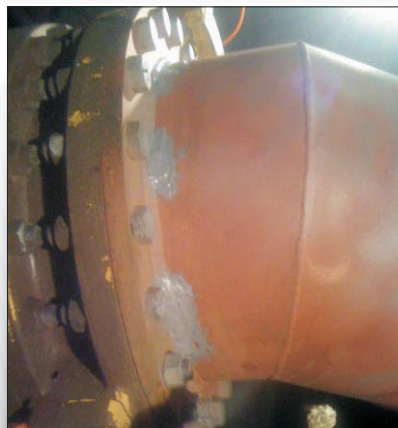
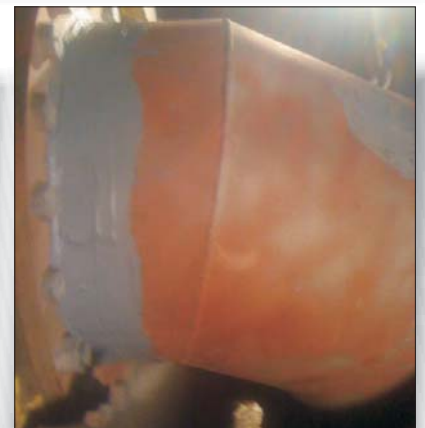
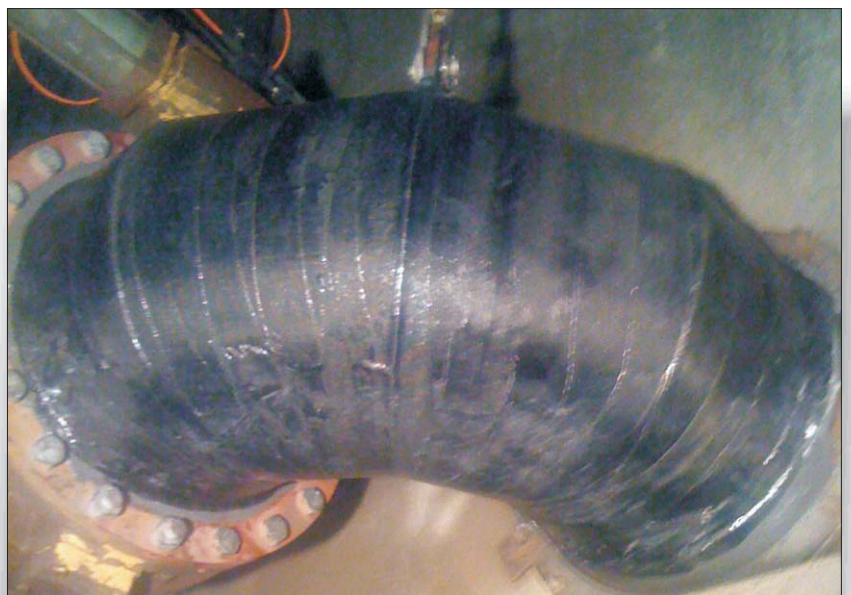
With over 40 such pipes in this plant, each of which is at least 40 years old, the facility engineers were looking for a fast, durable and cost effective repair and protection system.

The pipe was first prepared by brush blasting to remove all loose material and corrosion. Any holes in the pipe were sealed with **SpeedAlloy** followed by a reinforcement layer of **DurAlloy**.

After the **DuraWrap** primer was applied, the first coat of polymer saturated carbon fiber was used to wrap the pipe followed by the second layer.

The **DuraWrap** system saved the facility over \$90,000 by **repairing -- not replacing** the aging pipes.
