## Power Plant In The Philippines Chooses CHEMCLAD & CeramAlloy To Repair & Protect Critical FGD Pipeline

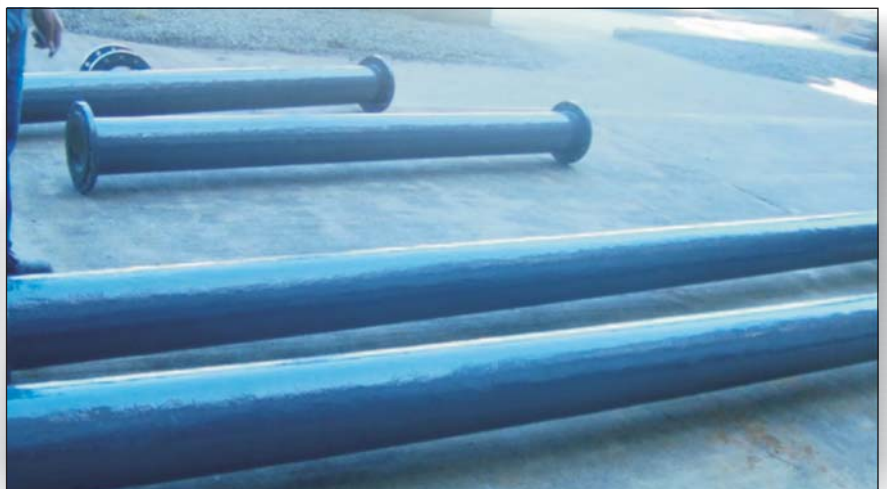
The make-up pipeline for the Flue Gas Desulfurization (FGD) section of this power plant in the Philippines was severely damaged by corrosion.

All components were first thoroughly prepared by grit blasting. An initial coat of CHEMCLAD SC was then applied to all surfaces.

CeramAlloy CP+[AC] was then applied to rebuild all the deeply pitted areas, followed by a final coat of CHEMCLAD SC to complete the application.
