DurAlloy & CHEMCLAD XC Repair & Protect Stainless Steel Fan Housing On Air Handler At Large Wastewater Treatment Facility

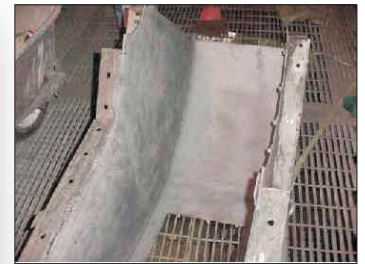
Surfaces were blasted to minimum 3 mil profile.

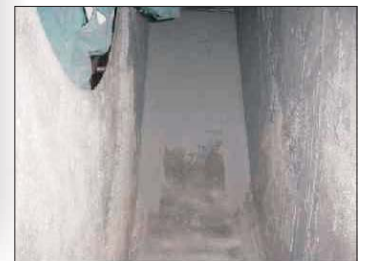
Interior was severely eroded, with many holes penetrating the walls. DurAlloy was used to rebuild all surfaces.

DurAlloy was used to repair all holes in the housing – some as large as 3/4 inch! Two coats of CHEMCLAD XC

were then applied to provide improved performance and long-term protection to this critical component.

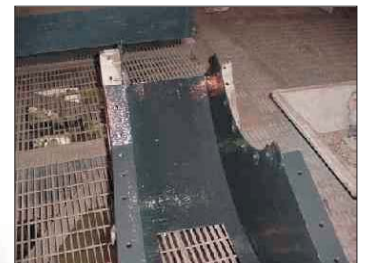
Two coats of CHEMCLAD XC were applied to all interior surfaces and flanges.
