Nevada Gold Mine Selects DuraQuartz & CHEMCLAD to Repair & Protect Chemical Containment Areas

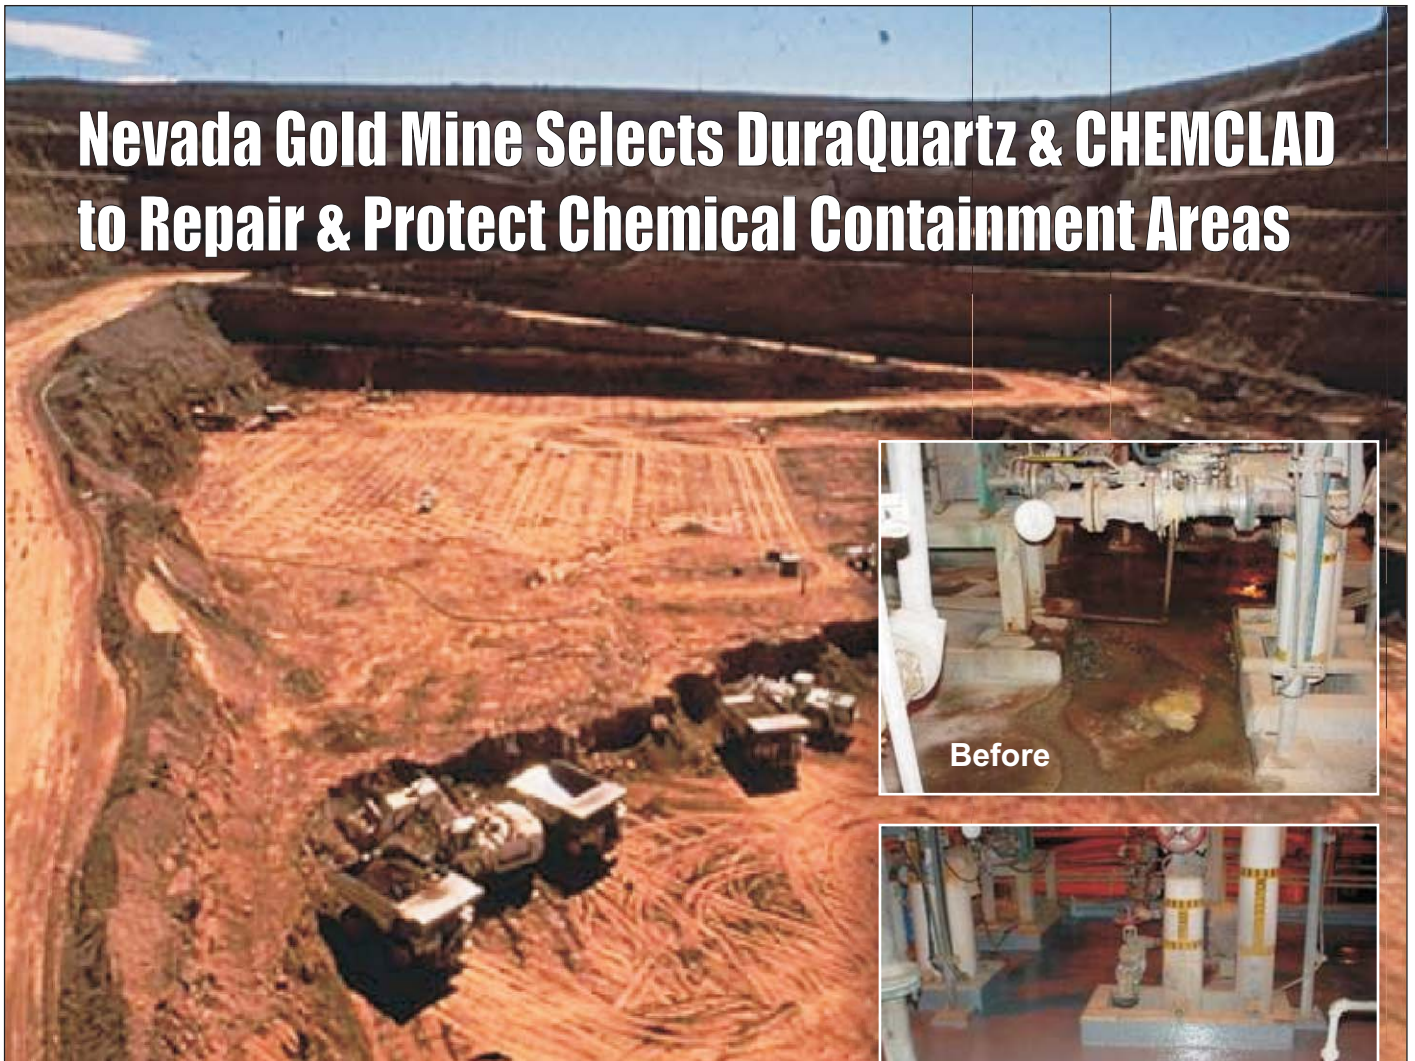
This concrete containment area was severely damaged by the strong chemicals used to strip gold from carbon ore. The chemical attack problems were exacerbated because the floor was pitched away from drains causing the chemicals to pool in certain areas.

Nevada's Team ENECON was called in to solve the problem. The containment

area was first water blasted to remove all chemical contamination as well as any loose or crumbling concrete. The drainage problems were corrected by using ENECRETE DuraQuartz to pitch the floor toward the drains.

Two coats of CHEMCLAD SC were then applied to prevent future chemical attack problems.
