U.S. Based Marine Company Uses CHEMCLAD SC to Salvage & Protect Pier Fender

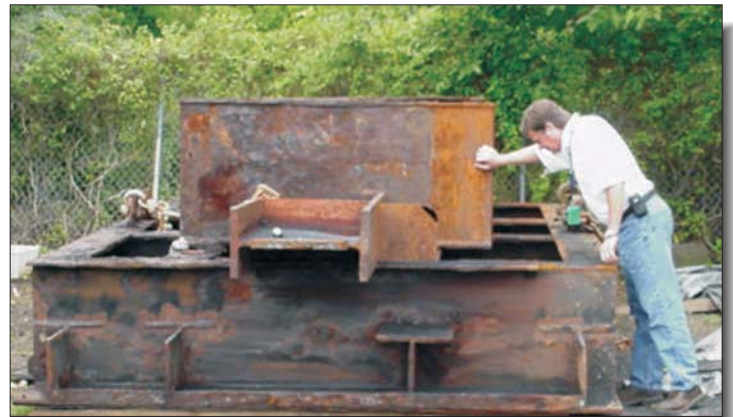
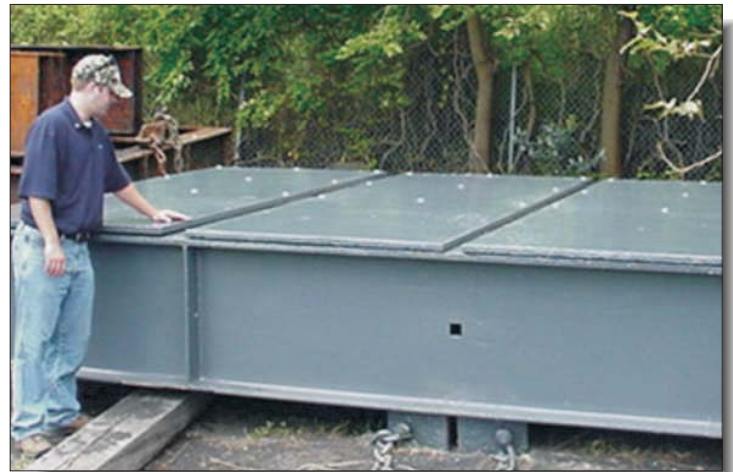
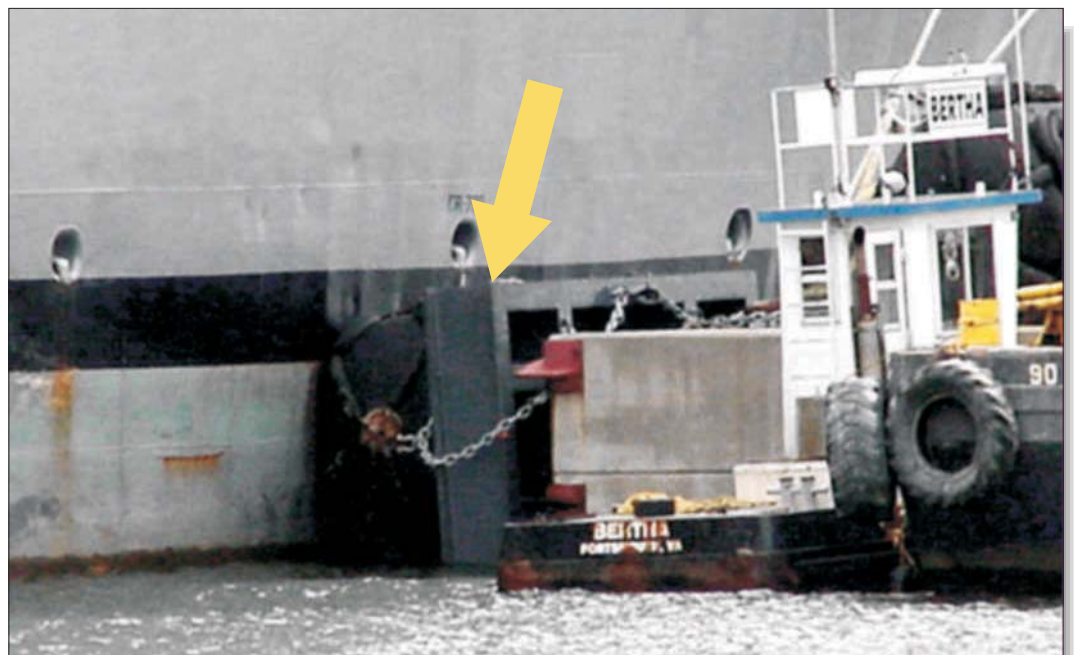
This 10 ton pier fender, used as a buffer between concrete pier pilings and boat hulls, was over 10 years old and suffering from severe erosion and corrosion due to constant exposure to salt water and tidal changes.

The ENECON Engineering Specialist recommended that all the fender's deteriorated steel be cut out and replaced. Then all surfaces were thoroughly grit blasted and cleaned.

The first coat of **CHEMCLAD SC** gray was applied by airless spray followed by a second coat of **CHEMCLAD SC** light gray. A total of 40 units were used for this application.
