Spanish Navy Protects Cargo Deck with CHEMCLAD SC Non-Skid Safety System.

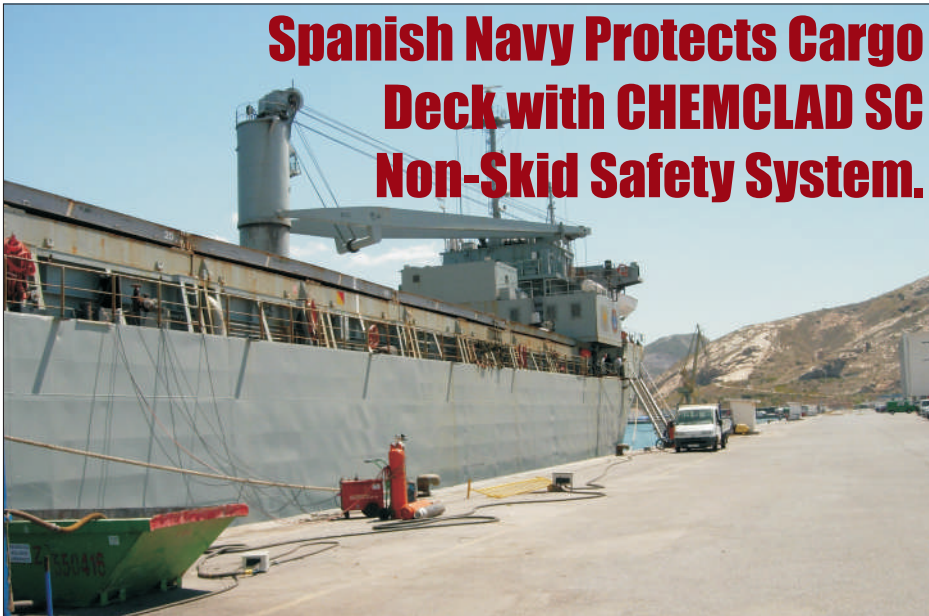
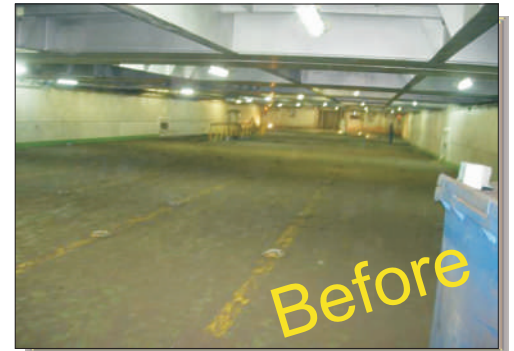
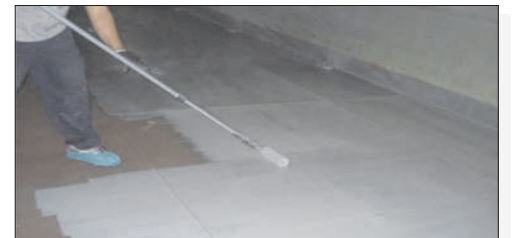
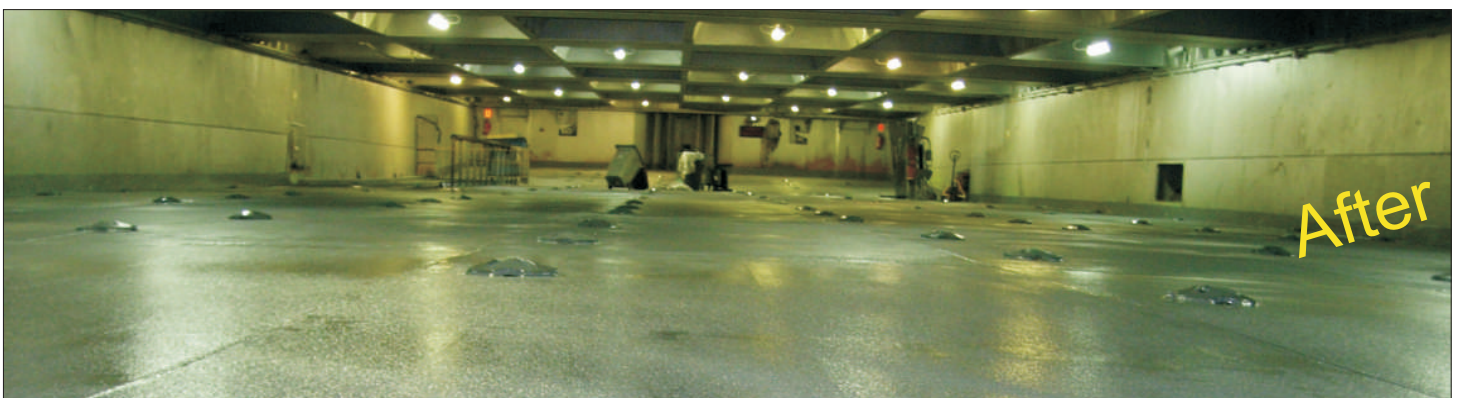
The hangar floor on this Spanish Naval vessel, used to transport tanks and other heavy vehicles, had been suffering from corrosion as a result of the failure of a conventional paint system.

The ENECON Specialist recommended that a complete *CHEMCLAD SC System*, incorporating aluminum oxide aggregate to provide slip-resistant safety surfacing, be applied to protect this floor from further corrosion damage.

The first coat of *CHEMCLAD SC* was rolled out. To provide slip-resistance, aluminum oxide aggregate was broadcast and back-rolled into the *CHEMCLAD SC* as it was applied.

A final topcoat of *CHEMCLAD SC* was then applied - giving the Navy a slip resistant,

easy to clean surface that would resist damage from gasoline, oil and hydraulic fluid while protecting the deck from corrosion for many years to come.
