## Philadelphia School District Repairs & Protects High Traffic Loading Dock With ENECRETE

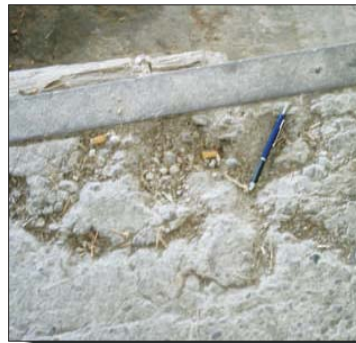
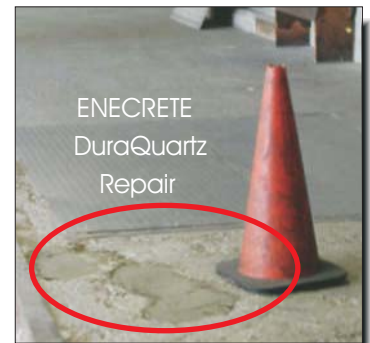
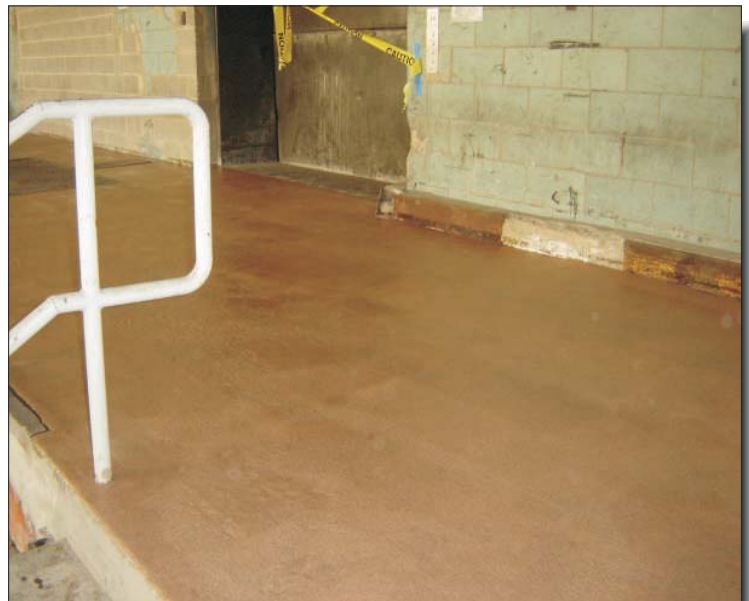
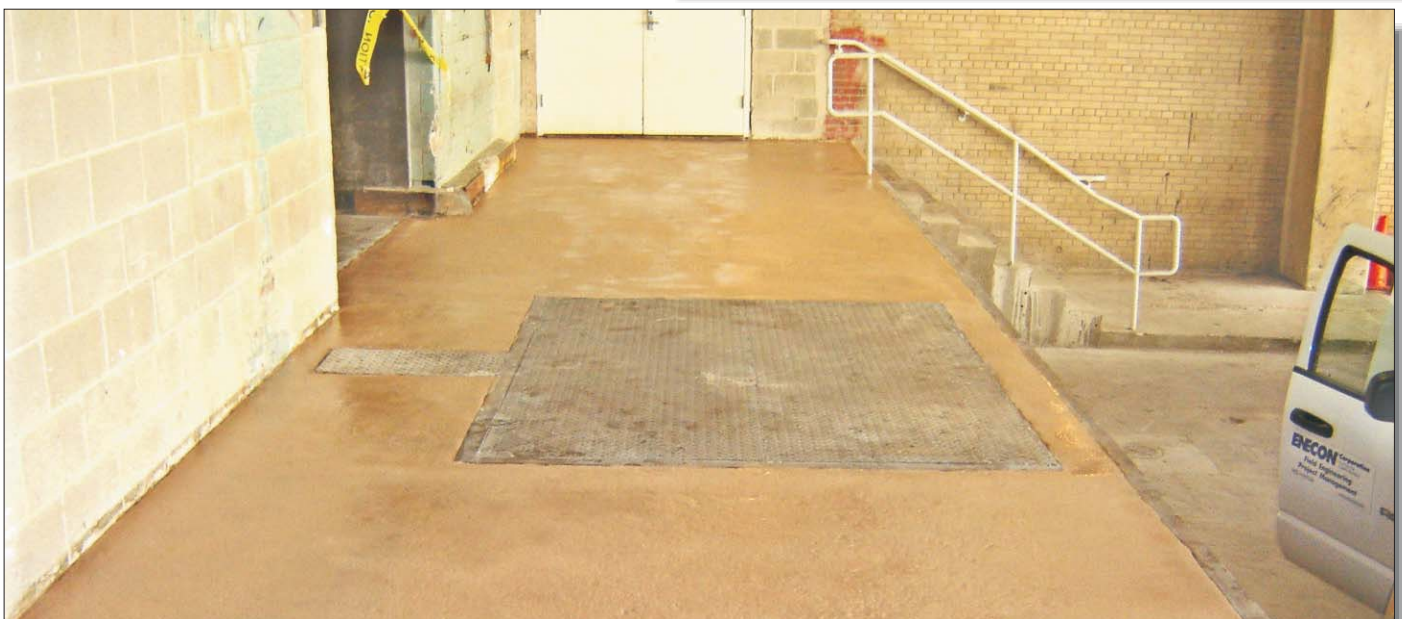
The condition of this busy loading dock was a safety concern to the maintenance engineers of a Philadelphia school district.

This loading dock is now a level, non-skid surface that no longer poses any threat as a potential tripping hazard. The school district engineers are very pleased with these results.

The local ENECON Field Engineering Specialist was consulted and it was recommended the holes on the loading dock first be repaired and leveled with DuraQuartz.

After the holes were successfully repaired, one coat of DuraFill was applied along with a single broadcast of a quartz and sand mixture. The final coat of DuraFill was then applied.
