Nuclear Power Plant in Spain Selects ENESEAL HR to Repair & Protect This Concrete Containment Building Dome

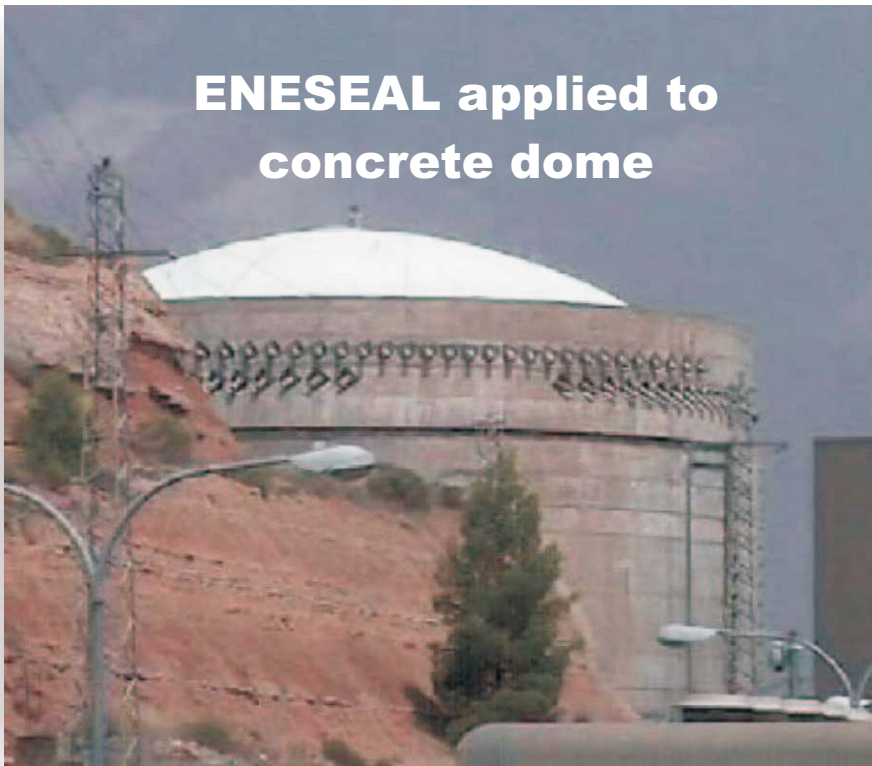
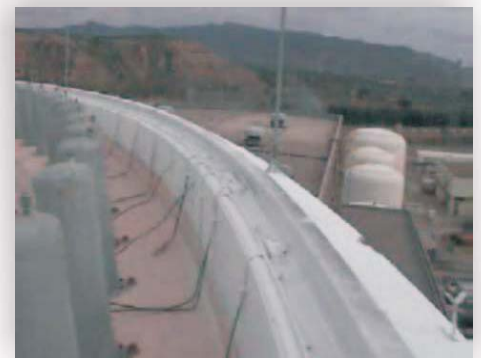
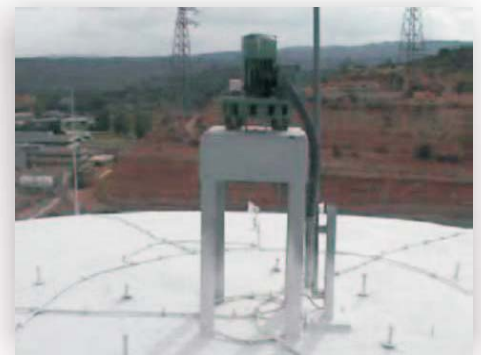
ENESEAL applied to concrete dome

The dome was thoroughly grit blasted by the ENECON Ibérica (Spain) Engineering Team and then

3 coats of ENESEAL HR were applied to completely encapsulate the dome, weatherproofing it and also providing a heat refractive shield to the concrete surfaces from the hot Mediterranean sun.
