Piping Repairs?... No Problem! It's as simple as 1-2-3 with ENECON METALCLAD Systems

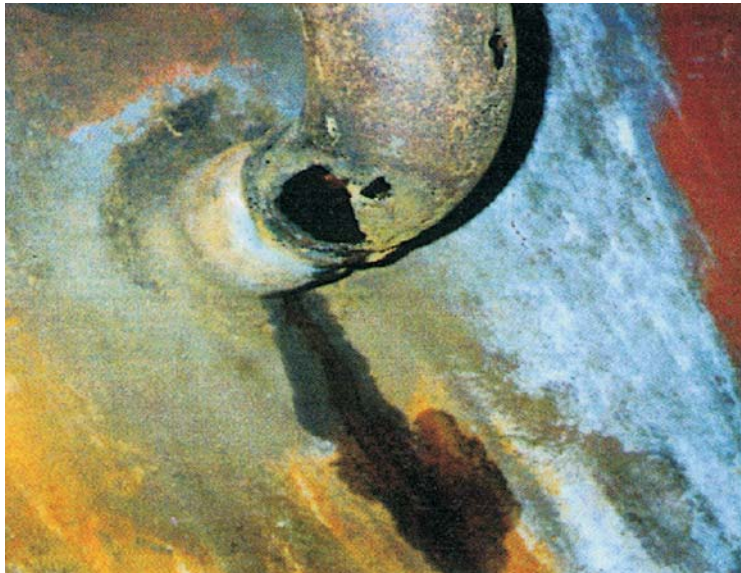
This severely pitted and corroded pipe elbow in the salt water fire fighting system on a ship proves no match for the capabilities of ENECON METALCLAD
