The Greek Navy Selects CeramAlloy & DurAlloy to Help Solve Some Very Difficult Repair Problems on Their Ships & Submarines

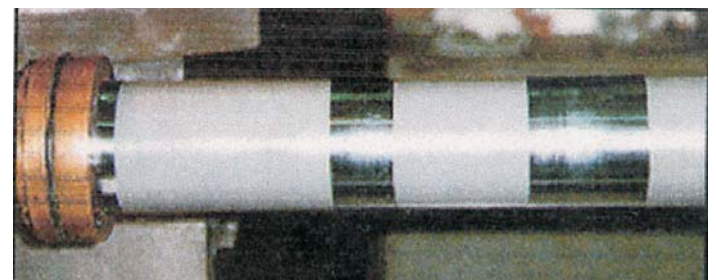
The second example highlights a repair to a damaged periscope piston from a Navy submarine. METALCLAD DurAlloy was used to rebuild the damaged areas saving the Navy a great deal of time and money when compared to conventional welding

or flame spraying repairs.

Of course, since DurAlloy requires **NO HEAT**, the danger of

warping the piston or creating metallurgical damage associated with welding was eliminated.
