## CeramAlloy Helps Salvage These Sewage Discharge Pipes at Main Pumping Station of a Major U.S. City

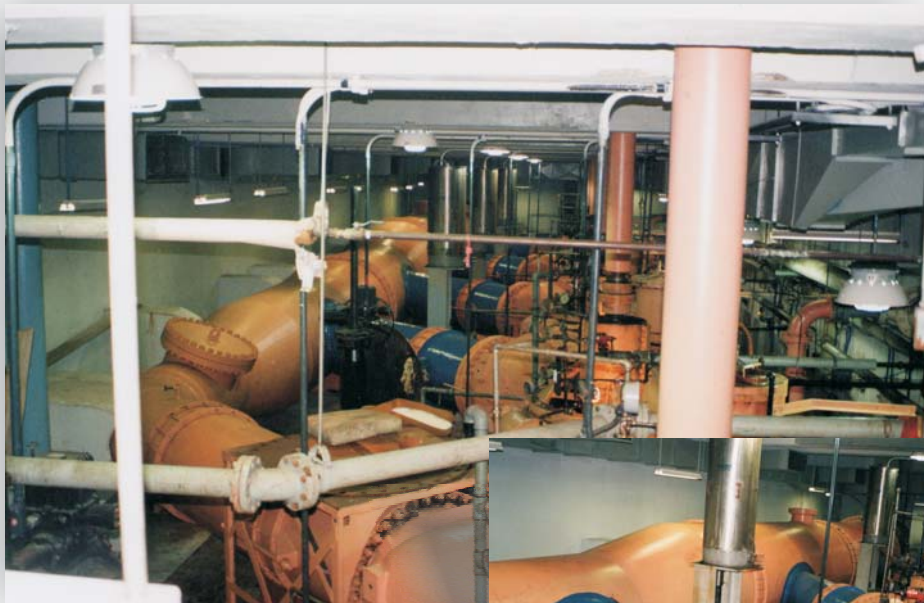
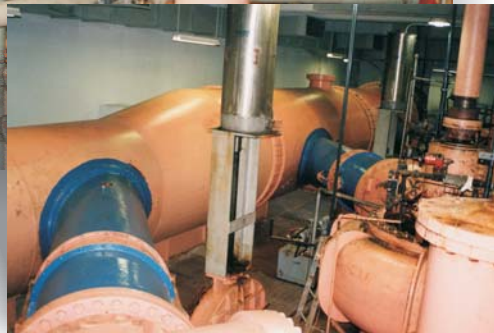
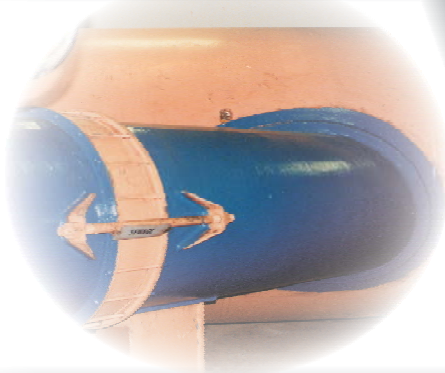
The ENECON North East Engineering Team was given a daunting challenge: to salvage this main pumping station's discharge pipes which were developing leaks due to the aggressive effluent as well as the age of the pipes, themselves.

The pipes were grit blasted and any leaks repaired with SpeedAlloy and DurAlloy. They were then 'wrapped' with CeramAlloy CL+ and fiberglass reinforcement tape to build up the wall thickness of the pipes. All the work was completed while the plant was fully operational. This project cost the plant a little over \$100,000, a small fraction of the million plus dollars which would have been needed to replace the pipes.

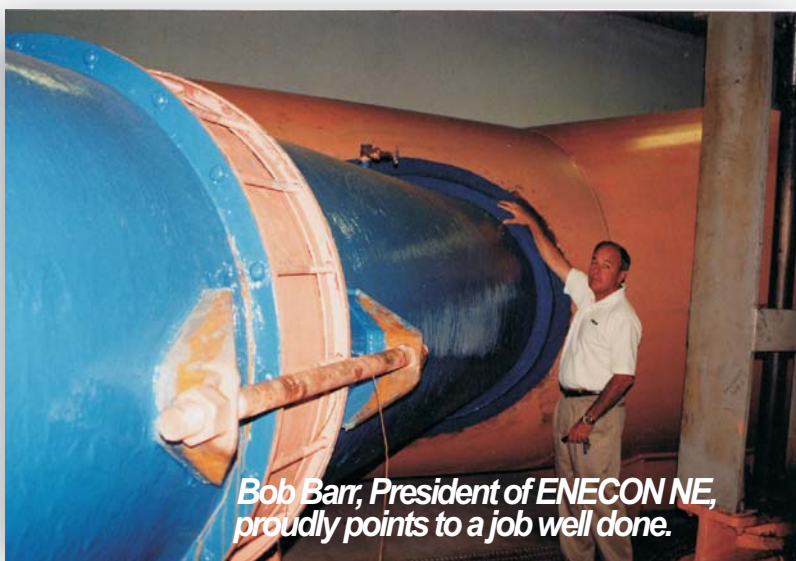
*Bob Barr, President of ENECON NE,  
proudly points to a job well done.*

Construction of a new pumping station has been delayed so what was looked upon as only a temporary repair has now provided trouble-free service to the plant since 1997.
