## Engineers at a Waste Water Treatment Plant Located in Philadelphia Repair Leaking Pipe Elbow with CeramAlloy

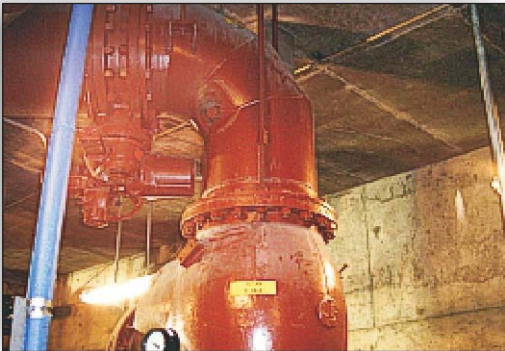
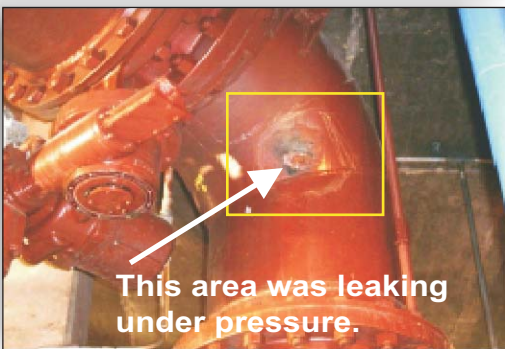
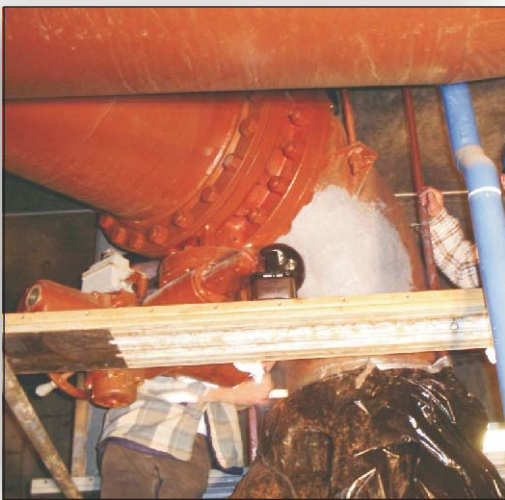
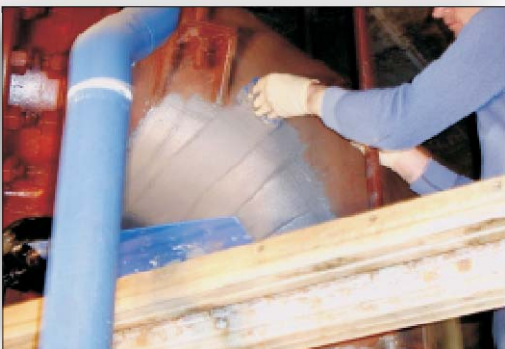
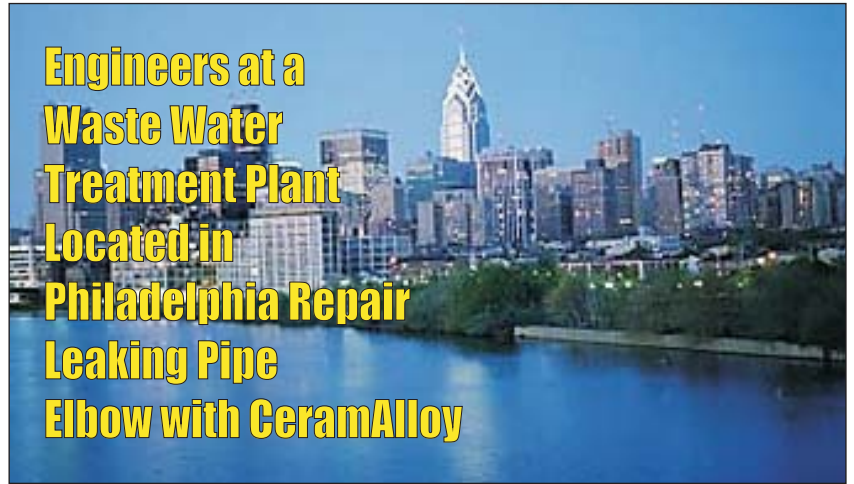
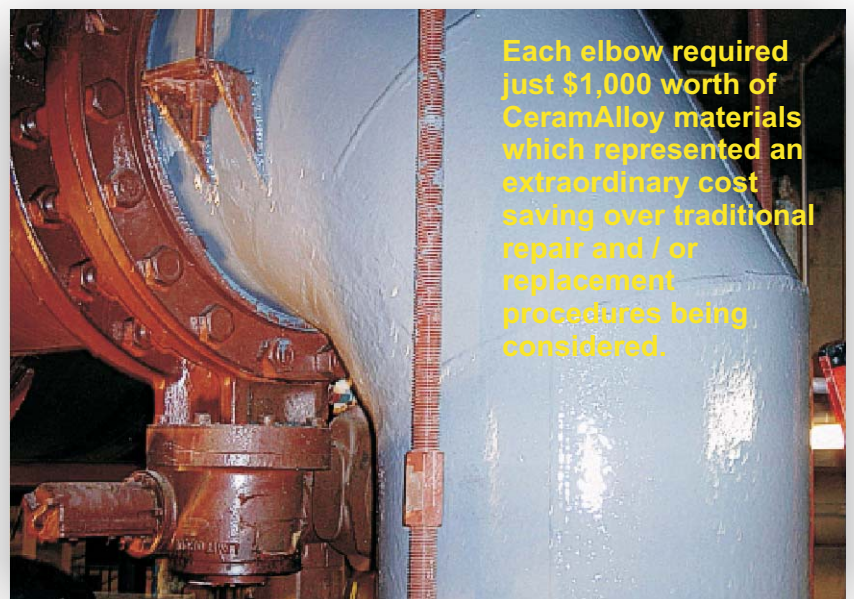
The maintenance engineers at this municipal waste water treatment facility needed a quick as well as cost effective repair on 8 RSP (Return Sludge Pump) exit elbows that had developed leaks. Removal and replacement was an expensive and time-consuming option that would have left the plant vulnerable

ENECON engineers suggested an unconventional solution: repair and rebuild the elbows with CeramAlloy CP + AC and CL + AC.

the plant's own maintenance engineering staff with in-field technical support provided by ENECON's Engineering Team.

Each elbow required just \$1,000 worth of CeramAlloy materials which represented an extraordinary cost saving over traditional repair and / or replacement procedures being considered.
