Military Sealift Command Vessel's Rudder Shafts Repaired & Protected With DurAlloy & CeramAlloy

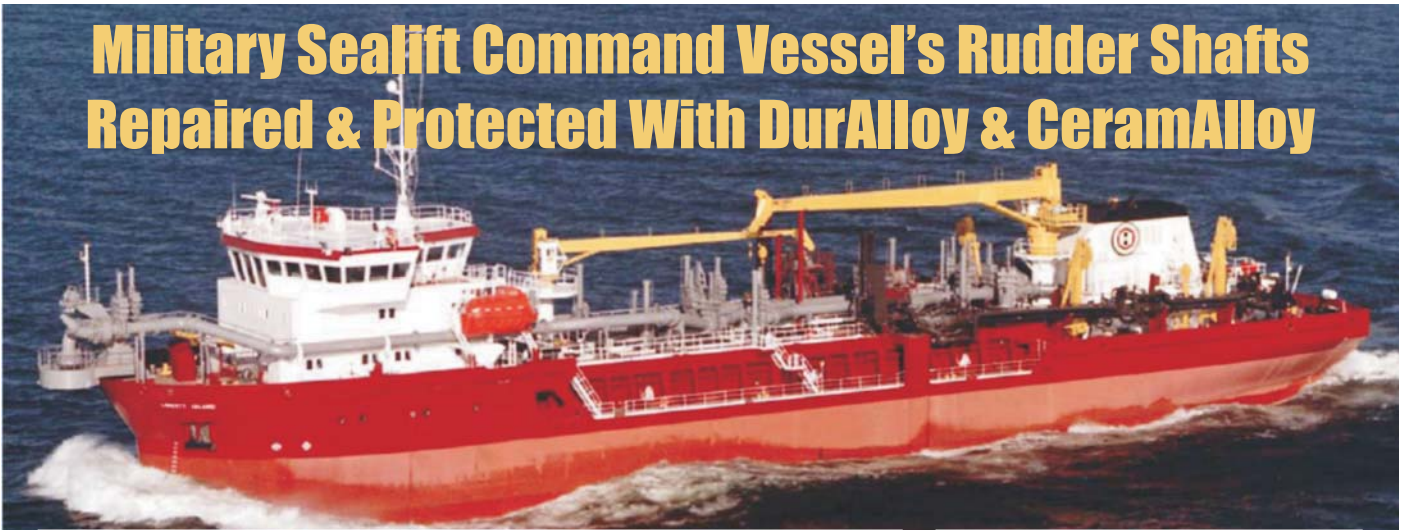
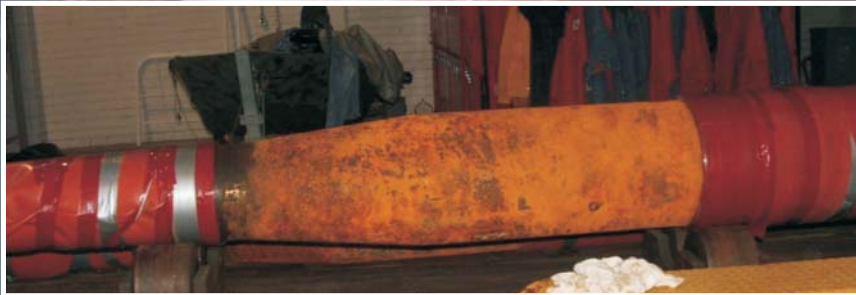
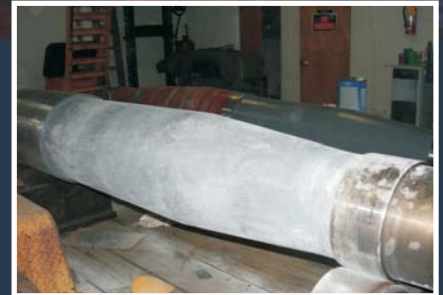
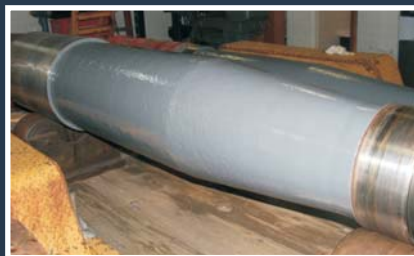
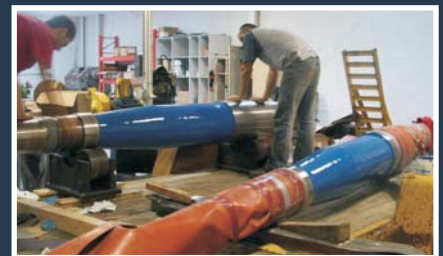
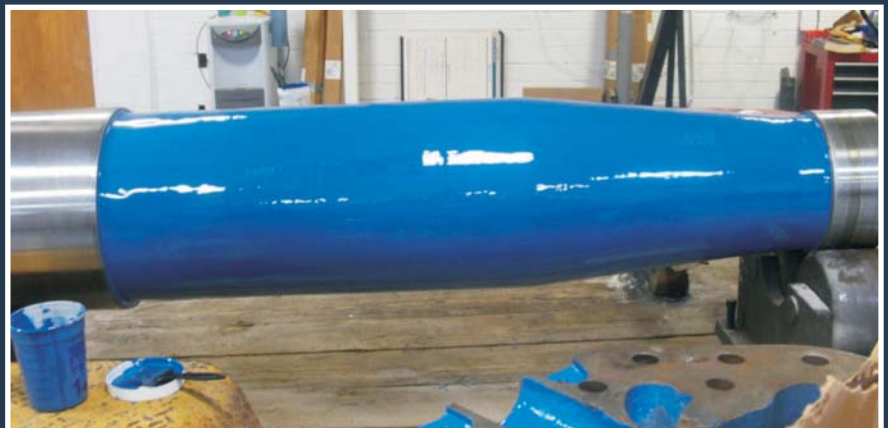
These pictures illustrate the repair procedure as well as the extraordinary final result.

The Military Sealift Command (MSC) needed to effect a cost effective repair on these two rudder shafts from a dredger. They contacted their local ENECON Engineering Team based in South Carolina who recommended using DurAlloy to rebuild the tapered shafts back to original specifications followed by the application of CeramAlloy CL+AC to provide a smooth, wear-resistant surface.
