U.S. Navy Saves \$37,000 On Emergency Heat Exchanger Repairs

The engineers on this Navy Frigate recently discovered that one of the bleed air heat exchangers was suffering from such severe erosion/corrosion damage that the unit was not cooling sufficiently.

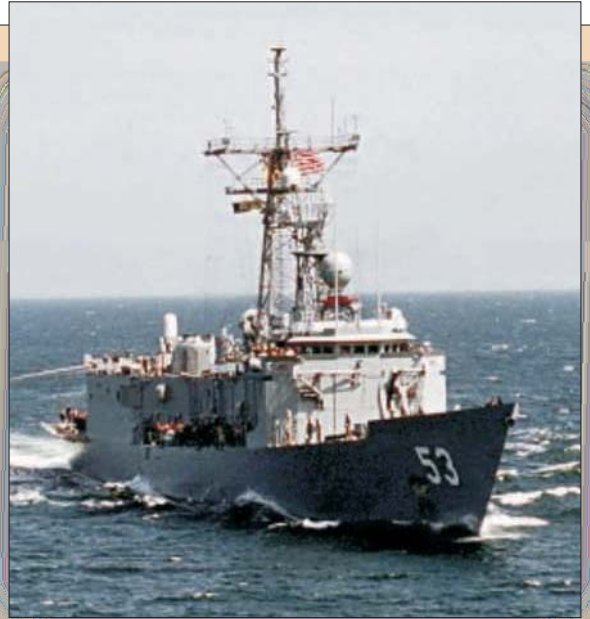
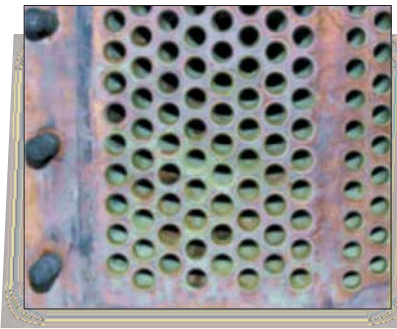
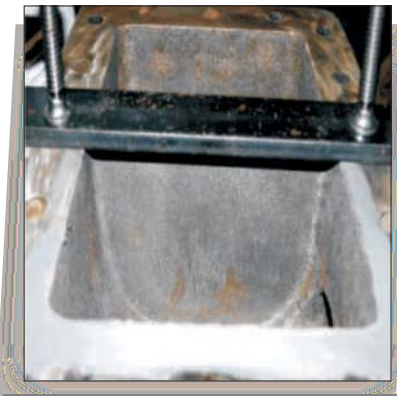
After the unit was grit-blasted, a 3 coat system of CeramAlloy CL+ was applied as illustrated in these photos. This entire project cost the Navy less than \$5,000.
